Boyne and Jordan Rivers Road Stream Crossing Inventory Project

Completed by Tip of the Mitt Watershed Council with support from:
Charlevoix County Community Foundation
May 2016

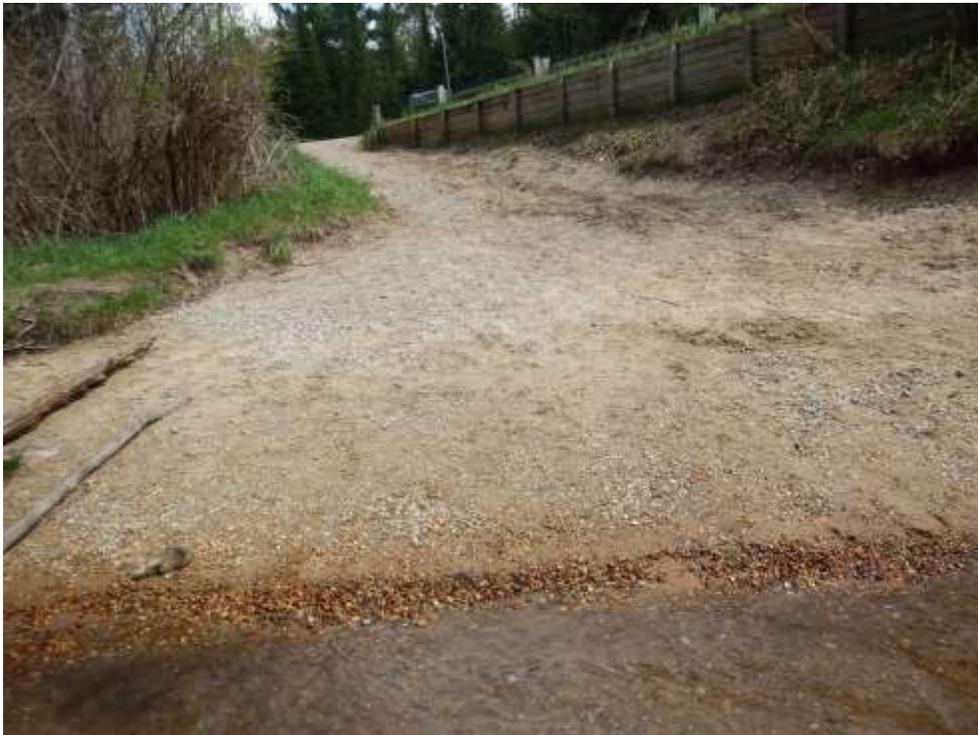
Figure 3: Jordan River at Old State Road Creek (JO-8)

Known locally as Chestonia Bridge, two 16' wide culverts currently sit where Old State Road crosses the Jordan River. These culverts along with eroding streambanks and worn access trails are causing unnatural stream changes and speed up stream flow to the point where some fish and other aquatic species cannot get upstream. As a popular canoe and kayak launch, this site has a high recreational value as well. Both the health of the river and making this a safe, accessible site for recreationists are top priorities.

- Erosion (tons/year): 8
- Fish Passage Determination: 0
- Extent of Erosion: Very severe
- Severity Calculation: Severe
- Structure Water Velocity: 5.28 ft./sec (inlet); 8.37 ft./sec (outlet)

- Engineering plans for the RSX are complete and include a full-span timber bridge along with recreational access.

Cost: \$1,200,000 based on estimates prepared for Conservation Resource Alliance in their pursuit of fully funding the project.

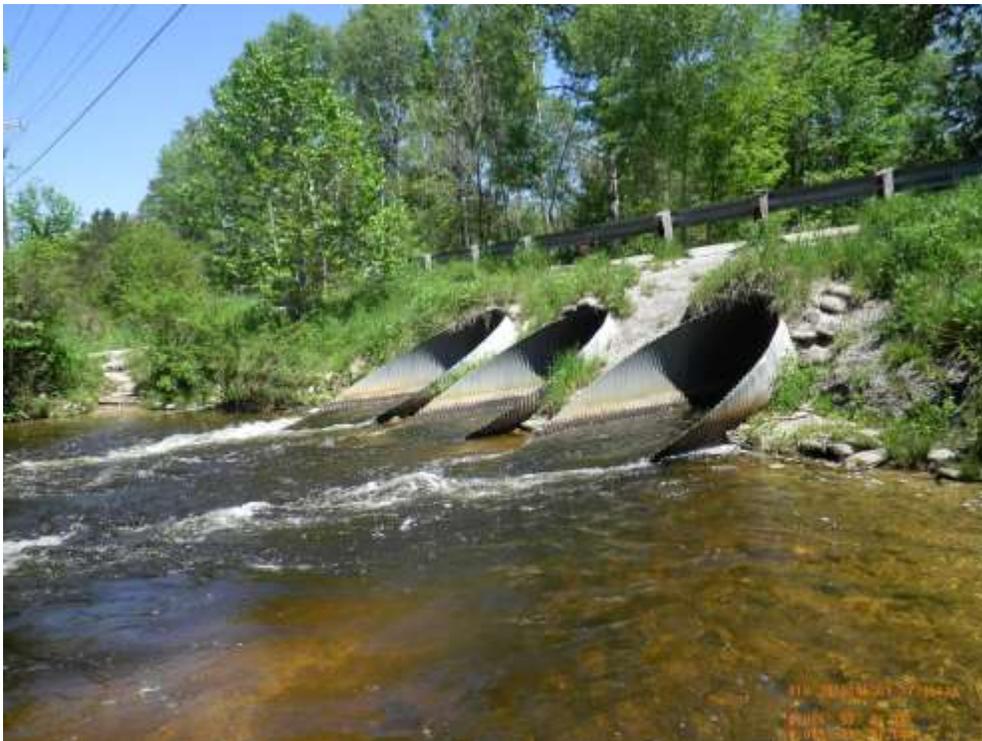
Figure 5: Boyne River at Dam Road (BV-12)

Current conditions include three, 8' wide by 7' high metal culverts. Located approximately ¼ mile upstream of the RSX are the U.S.A Power Plant Dam and its 80-acre impoundment. Both downstream and upstream of the crossing are very popular fishing areas. Friends of the Boyne River, Tip of the Mitt Watershed Council and other stakeholders have considered the Dam Road crossing to be a priority for restoration of the Boyne River. The proximity of the dam, however, detracts from potential fish passage funding programs because of the upstream barrier.

- Erosion (tons/year): 1.1
- Fish Passage Determination: 0
- Extent of Erosion: Moderate
- Severity Calculation: Severe
- Structure Water Velocity: 4.9 ft./sec (inlet); 5.8 ft./sec (outlet)

- A full-span timber bridge would allow passage of all fish species, prevent downstream erosion and upstream flooding immediately around the crossing, and allow hydrologic processes to restore channel geomorphology.

Cost: \$500,000 or more based on costs estimates for similar construction projects, such as the timber bridge constructed in 2012 in Emmet County across the Bear River.

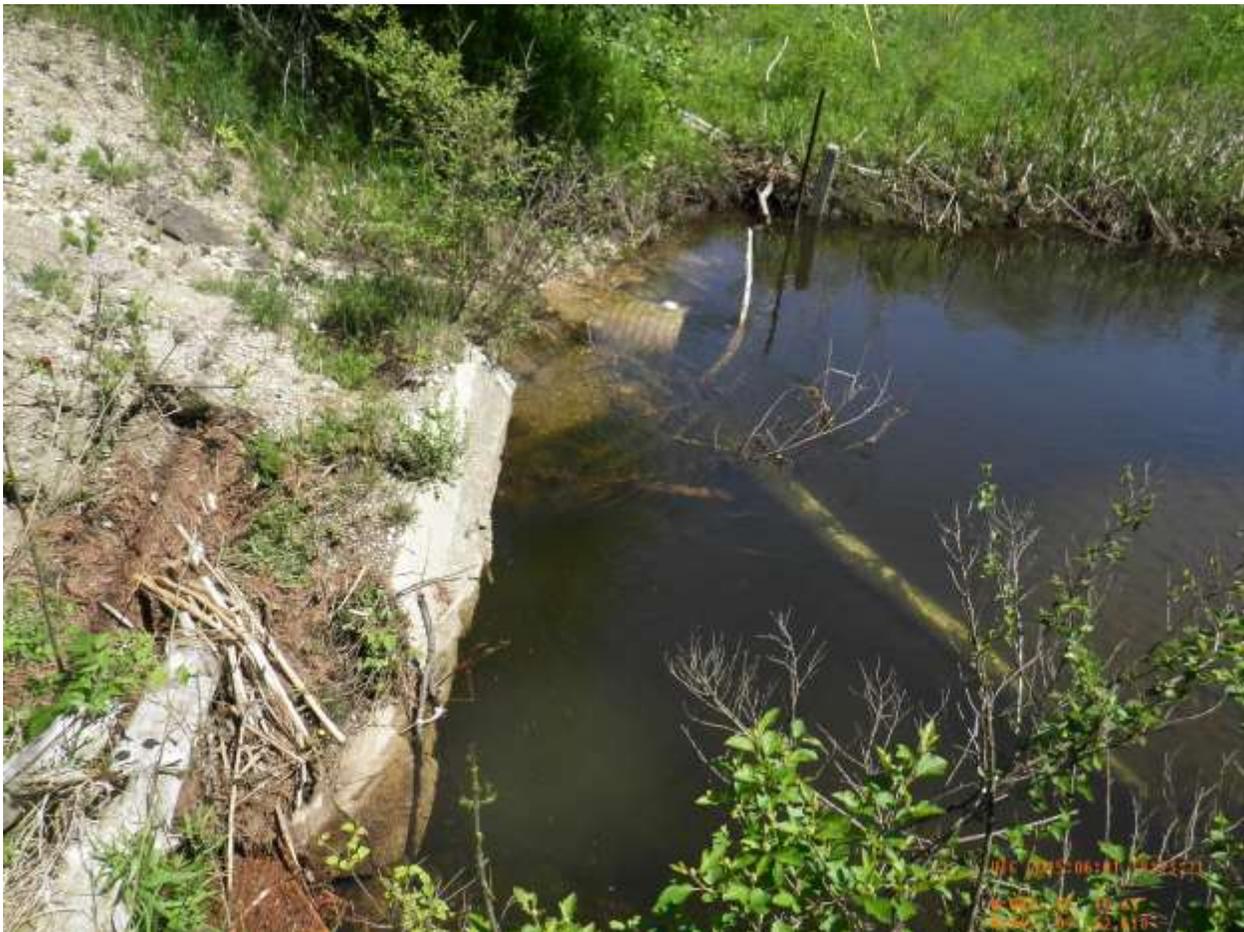
Figure 6: Boyne River at Cherry Hill Road (BV-14)

Current conditions include two metal culverts that are both submerged. One culvert is approximately 3½' x 2½'. The other culvert could not be measured as it was submerged well below the water's surface. The area immediately above the culverts (embankment) is eroding, likely due to recreational access.

- Erosion (tons/year): .2
- Fish Passage Determination: .5
- Extent of Erosion: Moderate
- Severity Calculation: Moderate
- Structure Water Velocity: 1.64 ft./sec (inlet); 2.1 ft./sec (outlet)

- The crossing once provided access to Boyne Mountain Resort, but it has since been abandoned. Given its condition and lack of usefulness, the RSX does not need to be replaced or upgraded. A pedestrian bridge could provide Boyne Mountain visitors a non-motorized connection to Boyne Falls., such as the timber bridge constructed in 2012 in Emmet County across the Bear River.

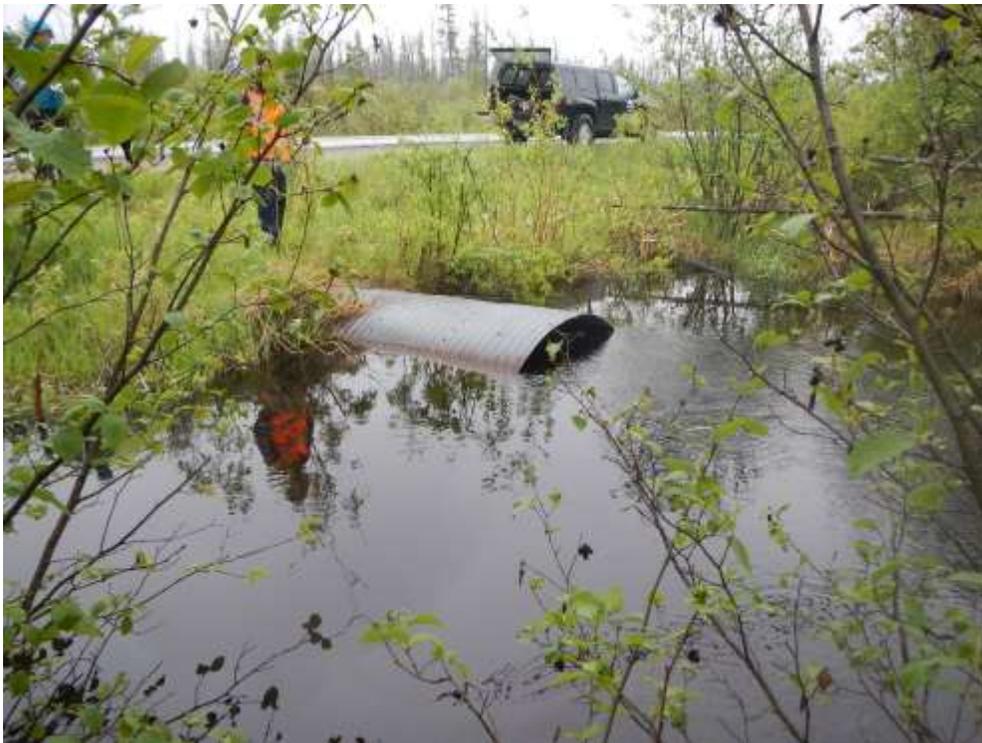
Figure 7: Collins Creek at Korthage Rd. (WI-32)

Current conditions include one undersized, metal culvert that is fully submerged at the inlet (and creating a whirlpool) and nearly fully submerged at the outlet. The culvert measures 6' wide x 5' high.

- Erosion (tons/year): .2
- Fish Passage Determination: .5
- Extent of Erosion: Minor
- Severity Calculation: Moderate
- Structure Water Velocity: 2.2 ft./sec (inlet); 2.5 ft./sec (outlet)

- The recommended RSX improvement includes a larger, bottomless elliptical culvert that both spans the width of the stream channel and has a bottom elevation that is flush with the stream bottom. These corrections would allow for fish passage, decrease erosion, and restore the local hydrology of the stream

Cost: \$180,000 based on cost estimates prepared for similar sites.

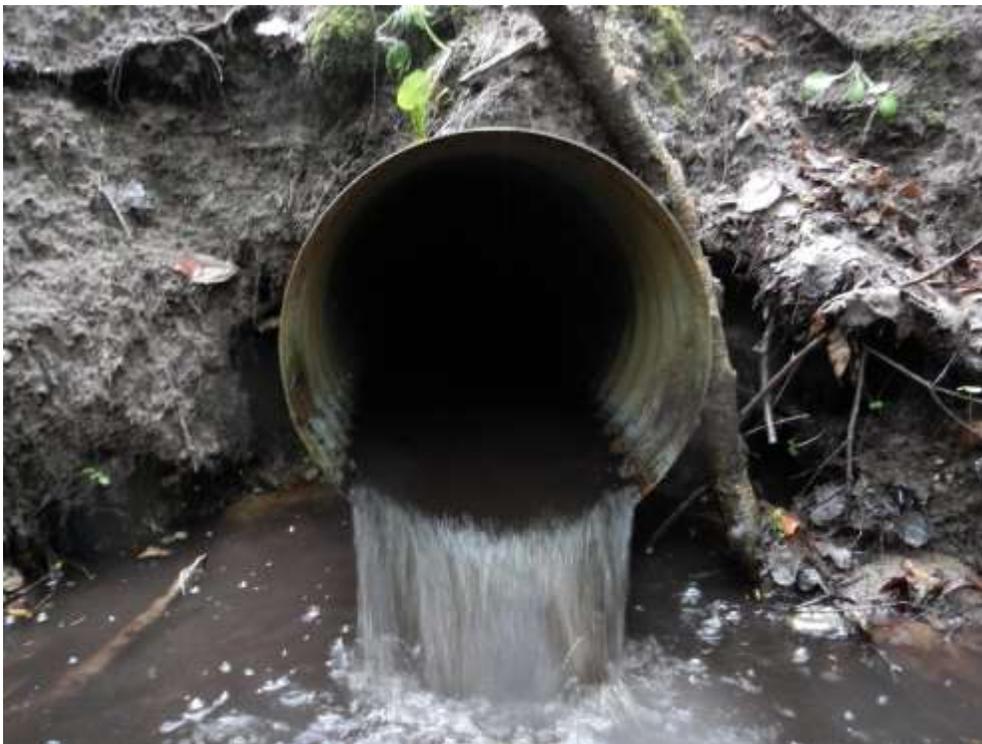
Figure 8: Brown Creek at Pesek Rd (WI-23)

One 18" metal culvert is perched (elevated) approximately 1.25' above the stream. Although the RSX is located on a rural road in the upper reaches of Brown Creek, corrections to this crossing would yield downstream benefits.

- Erosion (tons/year): 2.4
- Fish Passage Determination: 0
- Extent of Erosion: Moderate
- Severity Calculation: Severe

The recommended RSX improvement includes a larger, bottomless elliptical culvert that both spans the width of the stream channel and has a bottom elevation that is flush with the stream bottom. These corrections would allow for fish passage, decrease erosion, and restore the local hydrology of the stream

Cost: \$30,000 based on costs estimates prepared for similar sites.

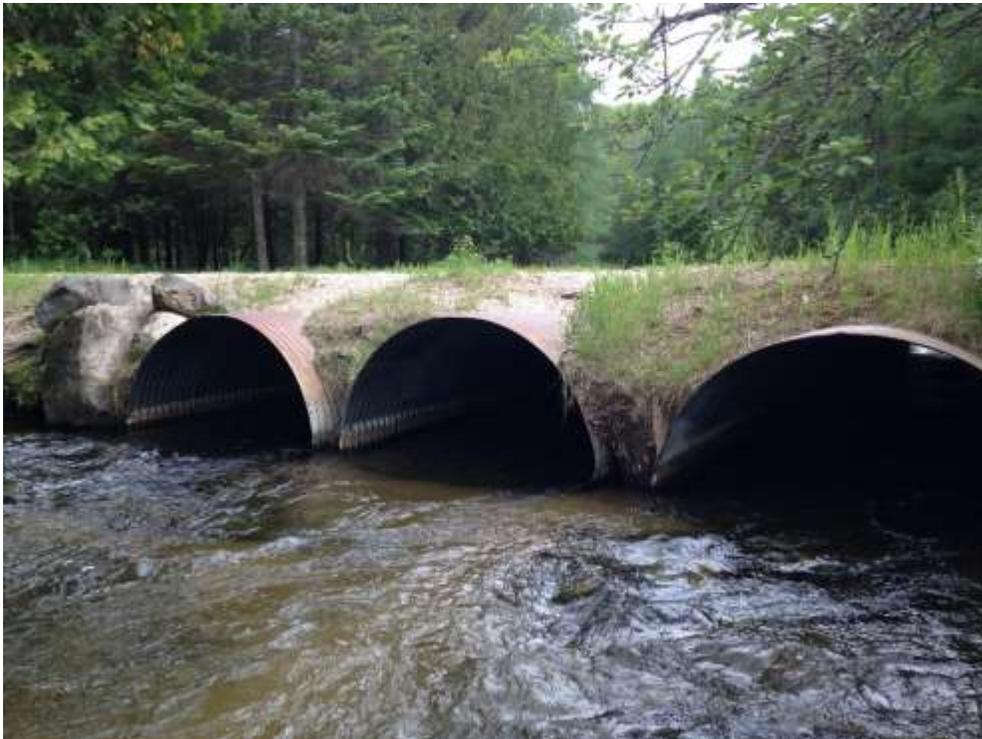
Figure 9: Jordan River and Jordan River Road (WA-5)

Current conditions include three undersized (6 ft. x 3.83 ft.) metal culverts.

- Erosion (tons/year): .3
- Fish Passage Determination: 0
- Extent of Erosion: Moderate
- Severity Calculation: Severe
- Structure Water Velocity: 3 ft./sec (inlet); 5.1 ft./sec (outlet)

- Replace culverts with 24-foot span by 6-foot rise precast concrete box culvert.

Cost: \$200,000 based on costs estimates prepared for similar sites.

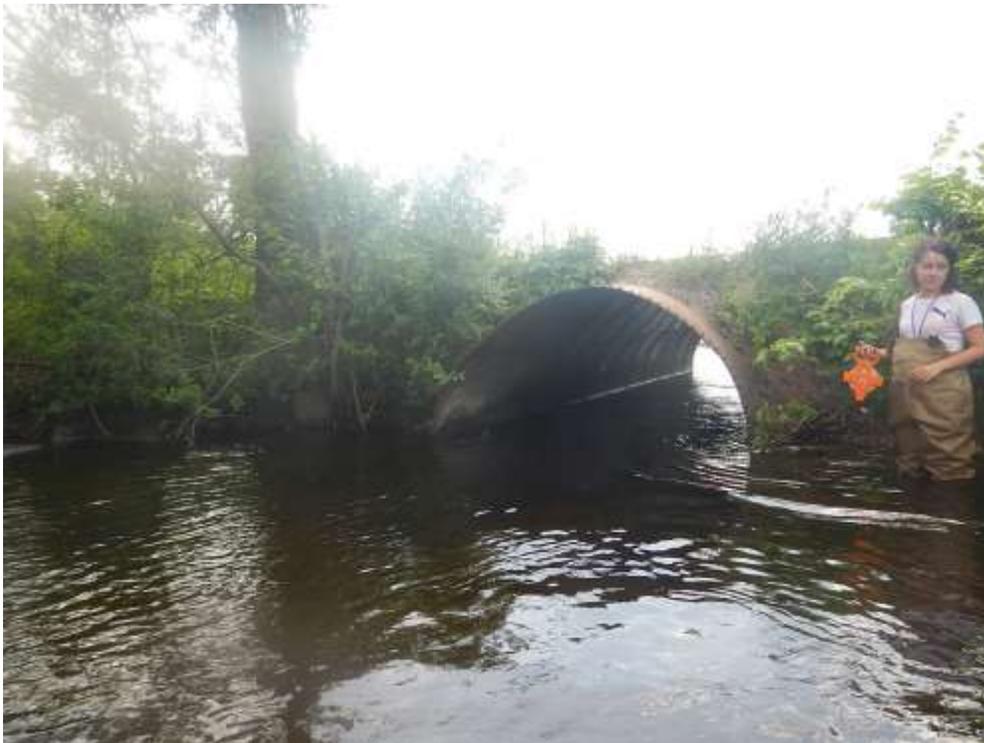
Figure 10: Deer Creek at Fuller Road (WI-28)

Current conditions include three undersized (6' x 3' 10") metal culverts.

- Erosion (tons/year): 14
- Fish Passage Determination: 0
- Extent of Erosion: Very Severe
- Severity Calculation: Severe
- Structure Water Velocity: 2.9 ft./sec (inlet); 3.1 ft./sec (outlet)

- Replace culvert with full-span timber bridge. Pave approaches (100' each side of crossing).

Cost: \$450,000 based on costs estimates prepared for similar sites and preliminary discussions with engineering firms.
