LAKE BELLAIRE SHORELINE SURVEY SUMMARY REPORT

Three Lakes Association
PO Box 689
Bellaire, MI 49615

by
William Bohannon,
Braden Ackerman,
Wilhelmina Witt
and
TLA Volunteers

August 30, 2008

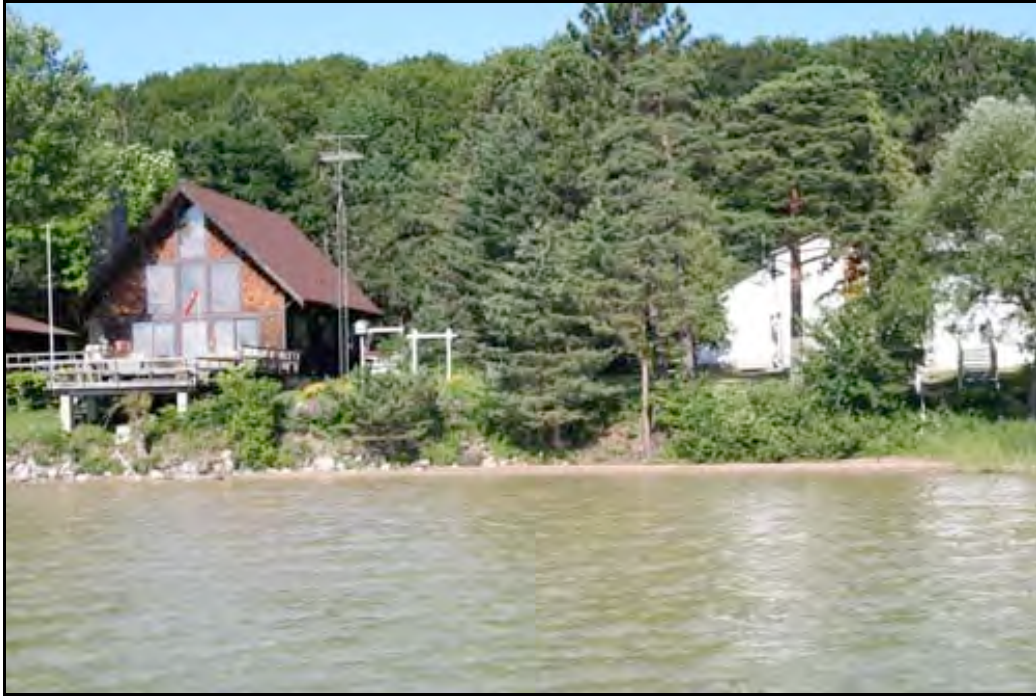
Developed Lake Bellaire Shoreline

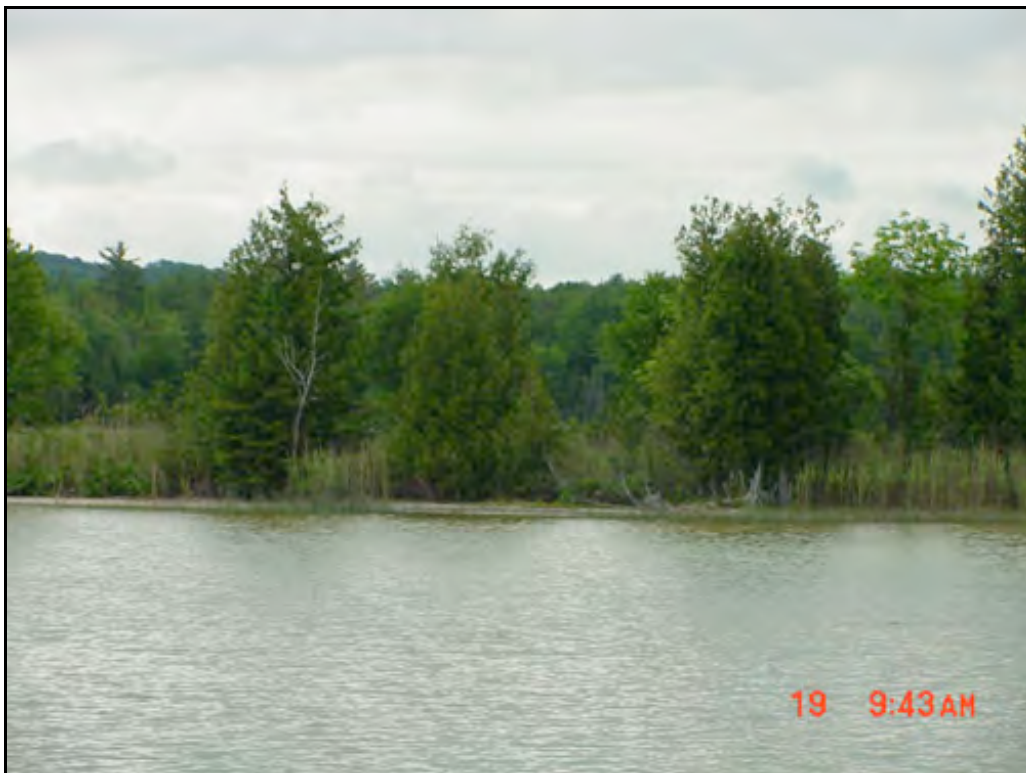
Undeveloped Lake Bellaire Shoreline

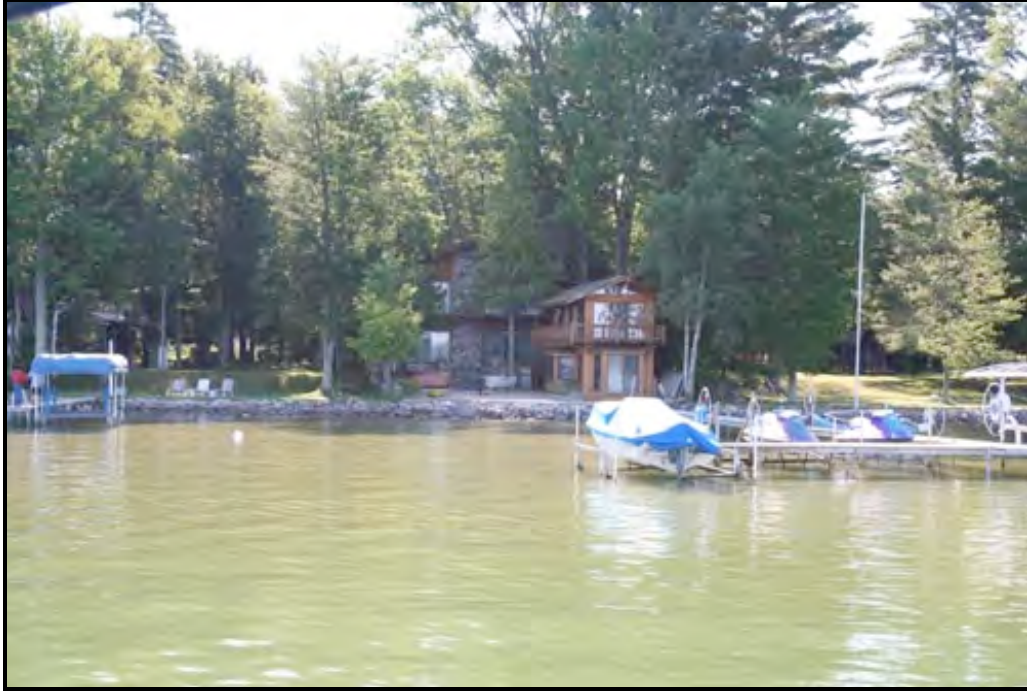
Landscaped region of Lake Bellaire Shoreline

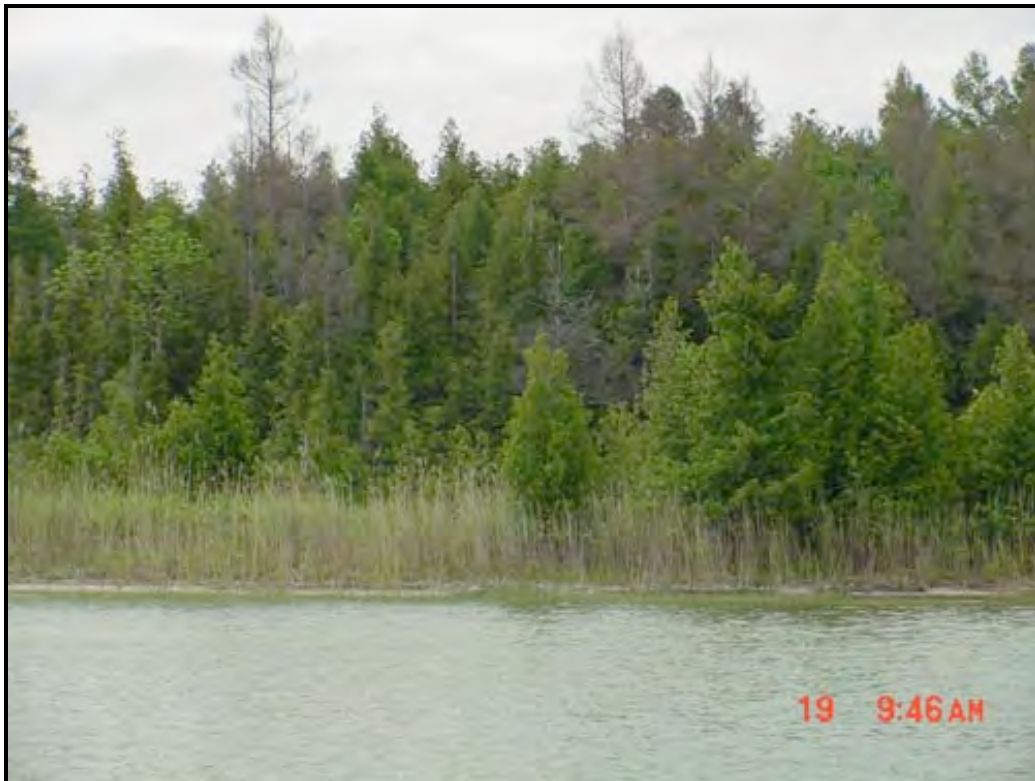
Natural region of Lake Bellaire Shoreline
