Road-Stream Crossing Inventory Results and Action Plan  
For The Grass and Rapid River Systems  
*Antrim and Kalkaska Counties*

***Report written by: Kevin L. Cronk  
Tip of the Mitt Watershed Council  
February 6, 2013***

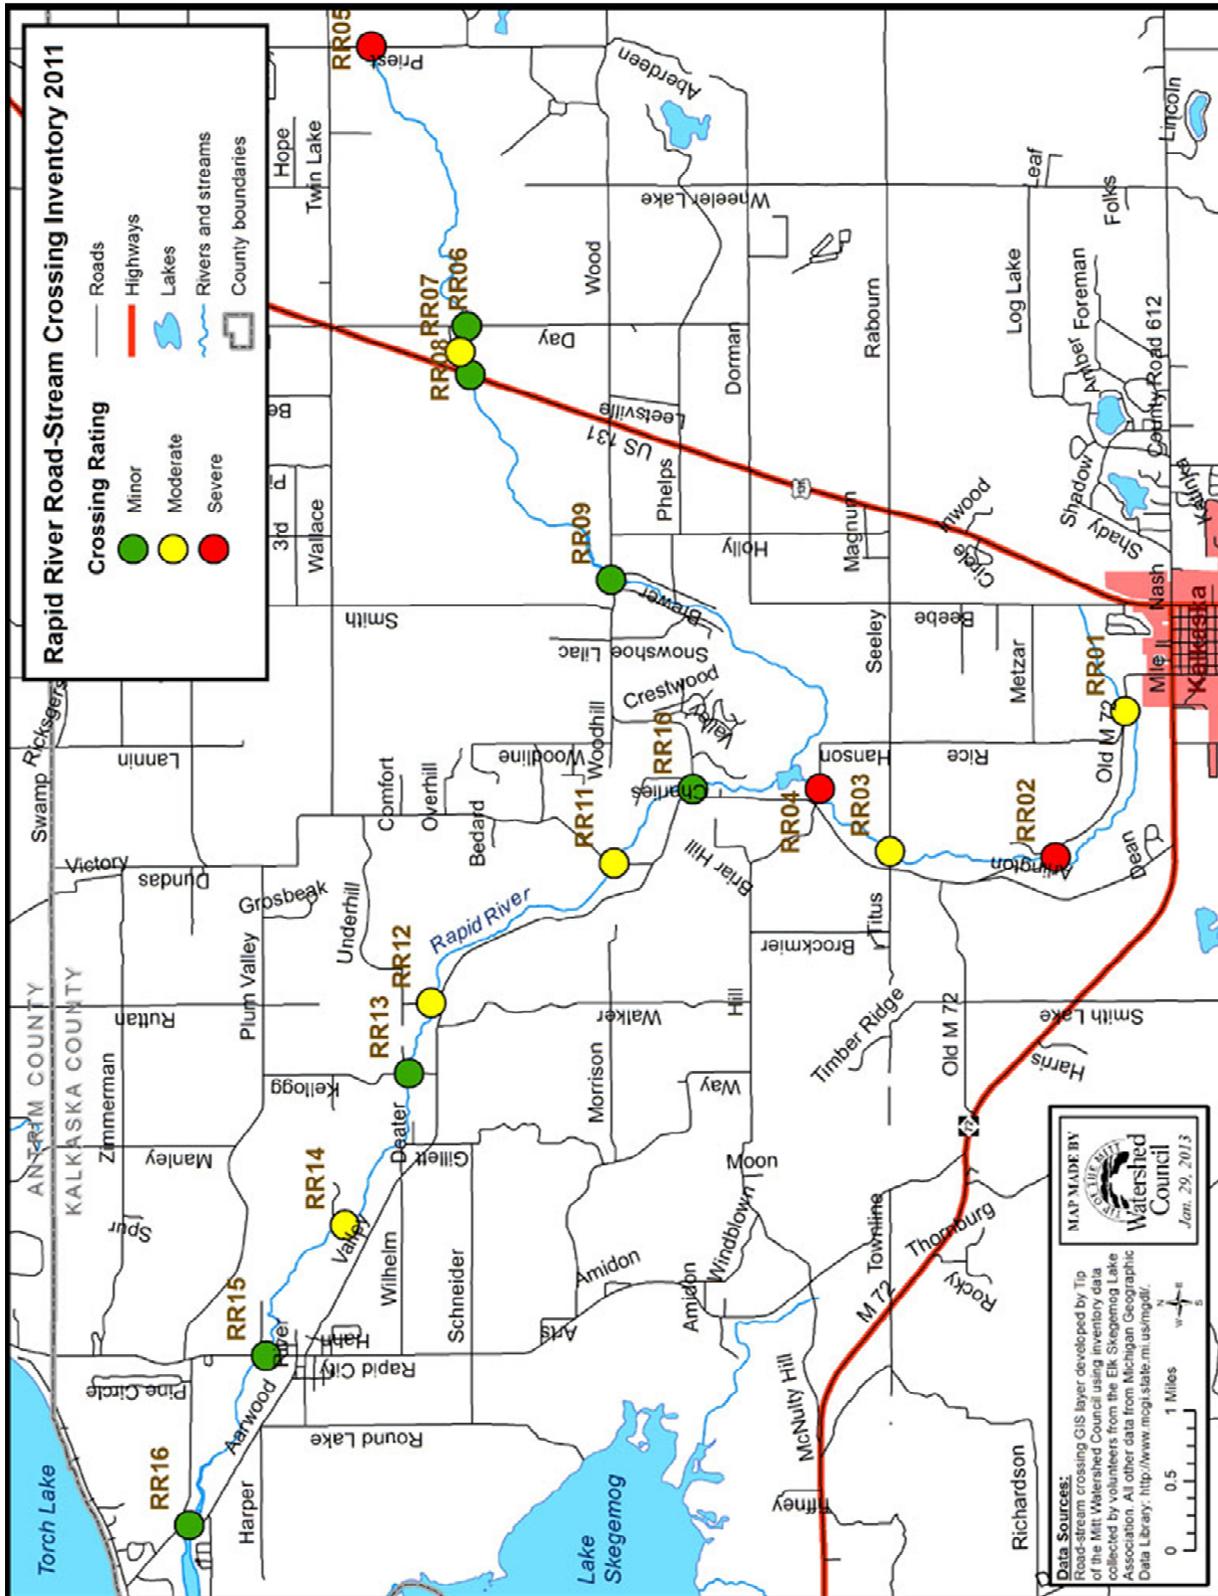
Figure 1. Results of the 2011 Rapid River Road-Stream Crossing Inventory.

In the Rapid River system, three road-stream crossing sites were rated as severe and six as moderate (Figure 1). Those rated as severe include two sites on the Little Rapid River at Old M72 near Valley Road (Site ID# RR02) and Hill Road (Site ID# RR04), as well as one site on the North Branch at Priest Road (Site ID# RR05). The six moderate sites include Old M72 near Kalkaska (Site ID# RR01) and Seeley Road (Site ID# RR03) on the Little Rapid River, the railroad crossing on the North Branch (Site ID# RR07), and Dundas Road (Site ID# RR11), Underhill Road (Site ID# RR12), and Glade Valley Road (Site ID# RR14) on the main stem.

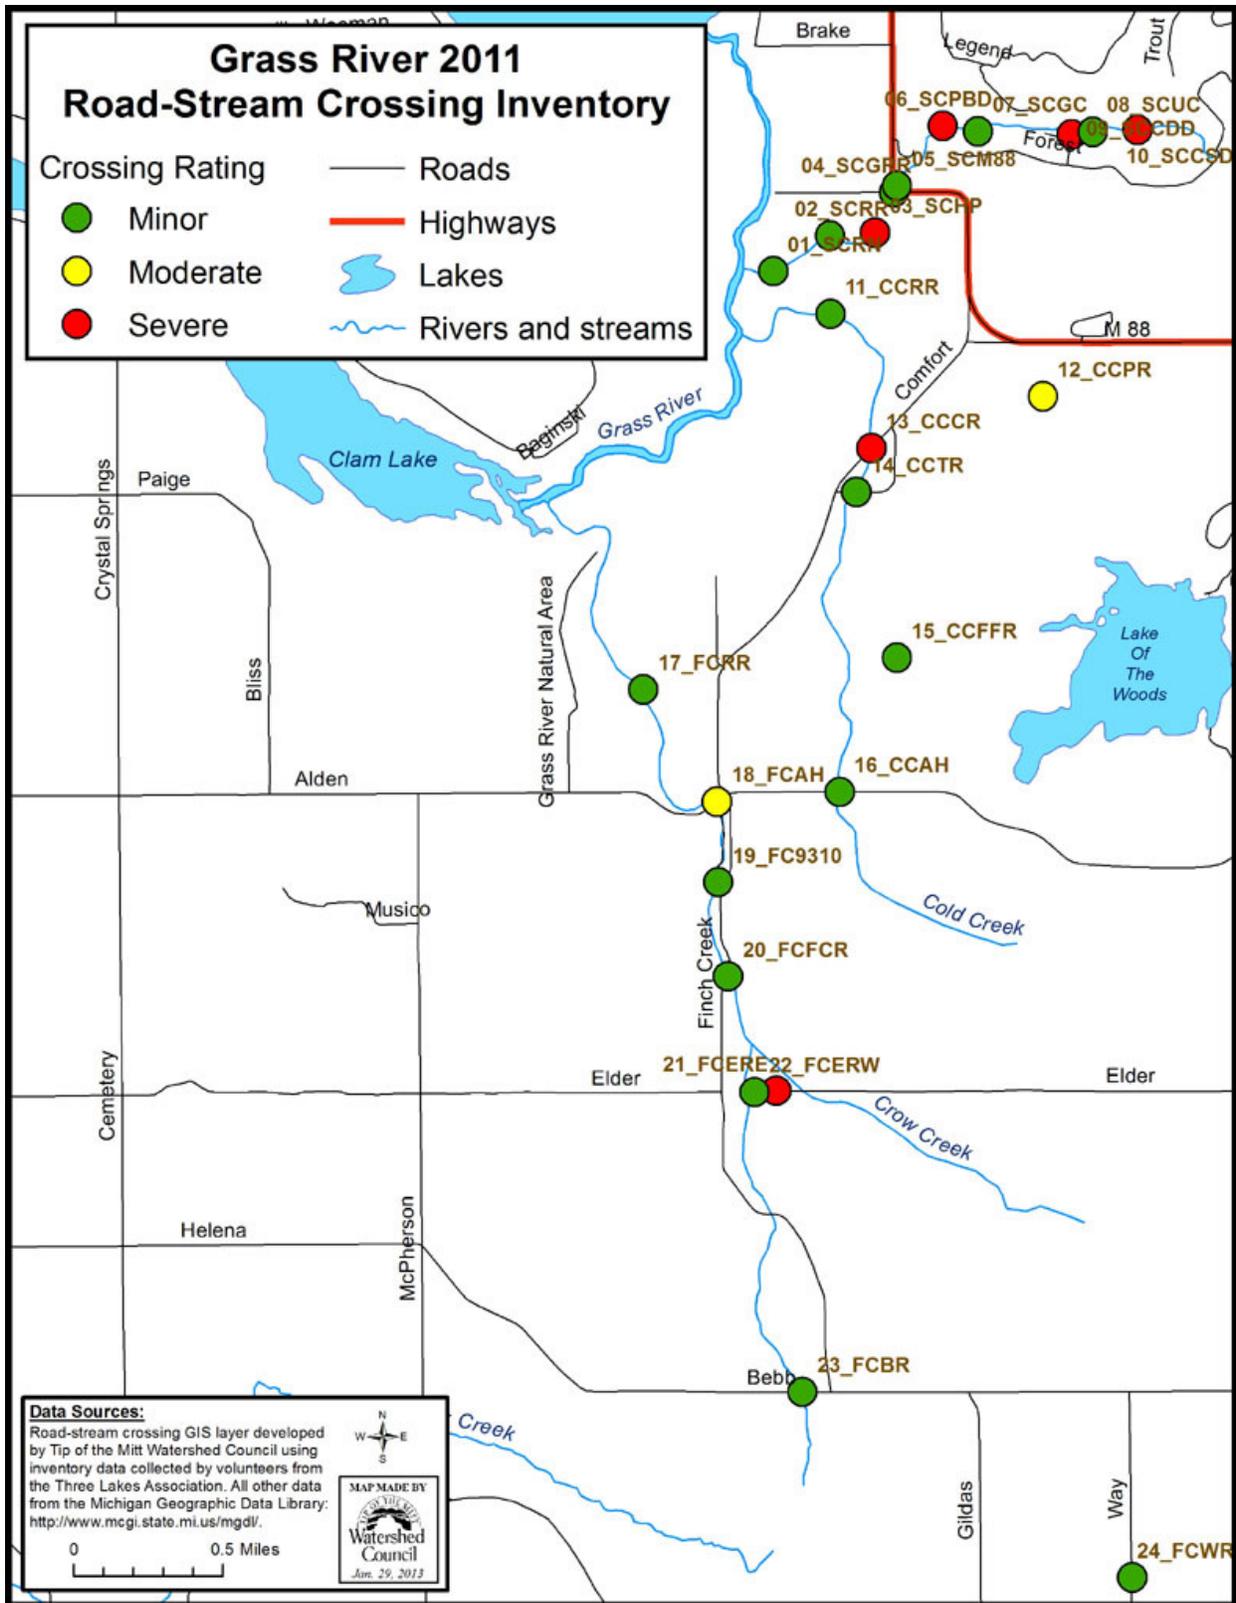
Figure 2. Results of the 2011 Grass River Tributary Road-Stream Crossing Inventory.

In the Grass River system, problematic road-stream crossings were most prevalent in the Shanty Creek Watershed where four of the ten crossings were rated as severe in terms of negative impacts to the stream ecosystem (Figure 2). These include an old hydropower site with a dam (Site ID# 03\_SCHP), another dam at Pine Brook (Site ID# 06\_SCPB), and two sites on Creekside Drive (Site ID# 09\_SCCSD and 10\_SCCSD). Cold Creek had one site rated as severe on Comfort Road (Site ID# 13\_CCCR) and a moderate site on an unnamed road (Site ID# 12\_CCCR). Finch Creek also had one site rated as severe on Elder Road (Site ID# 21\_FCERE) and a moderate site on Alden Highway (Site ID# 18\_FCAH).

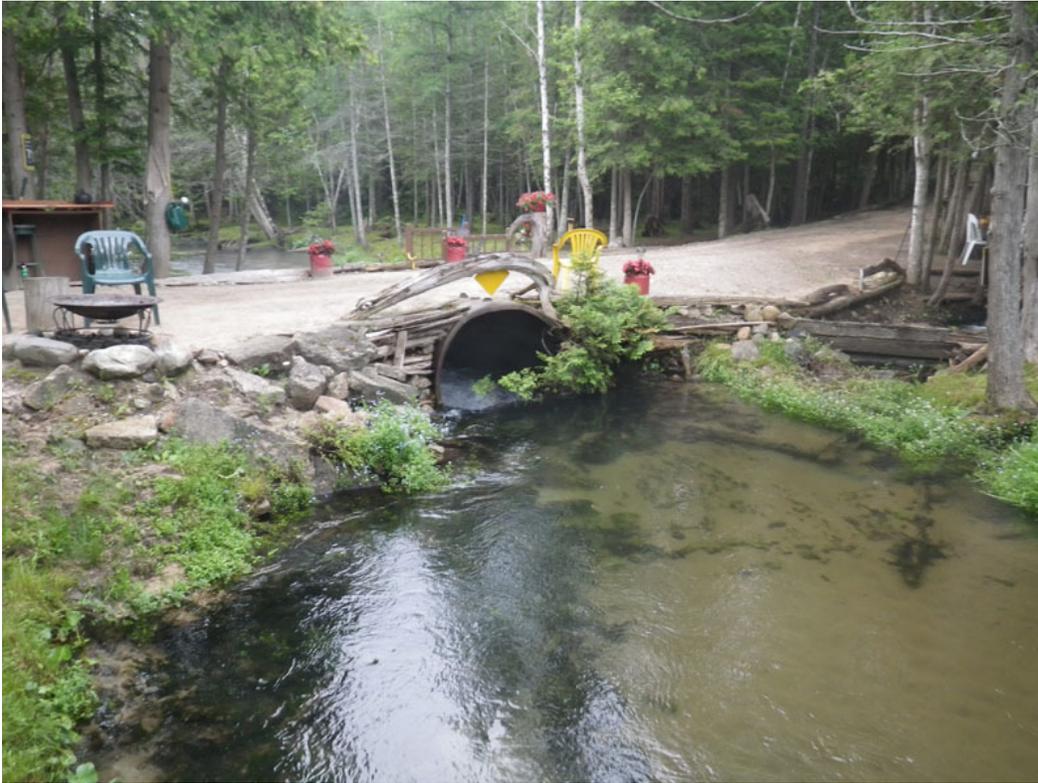
*Culvert inlet and scouring pool on private road on Cold Creek.*

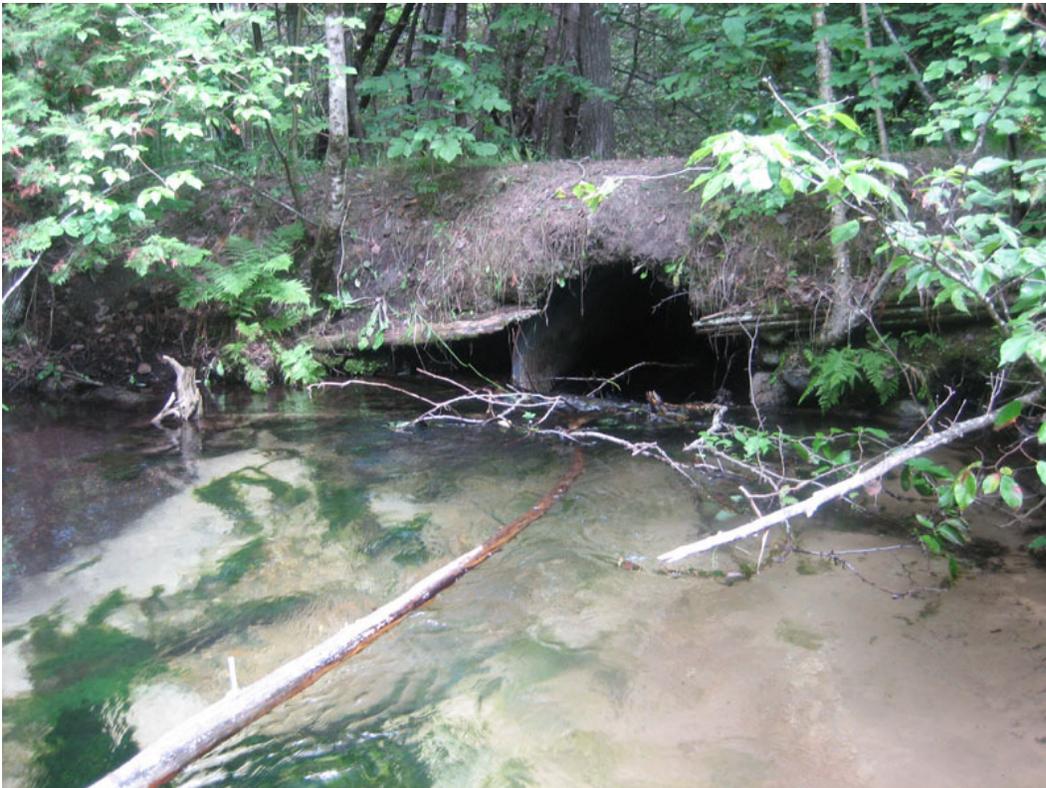
*Culvert inlet with eroding upper bank at Elder Road East on Finch Creek.*

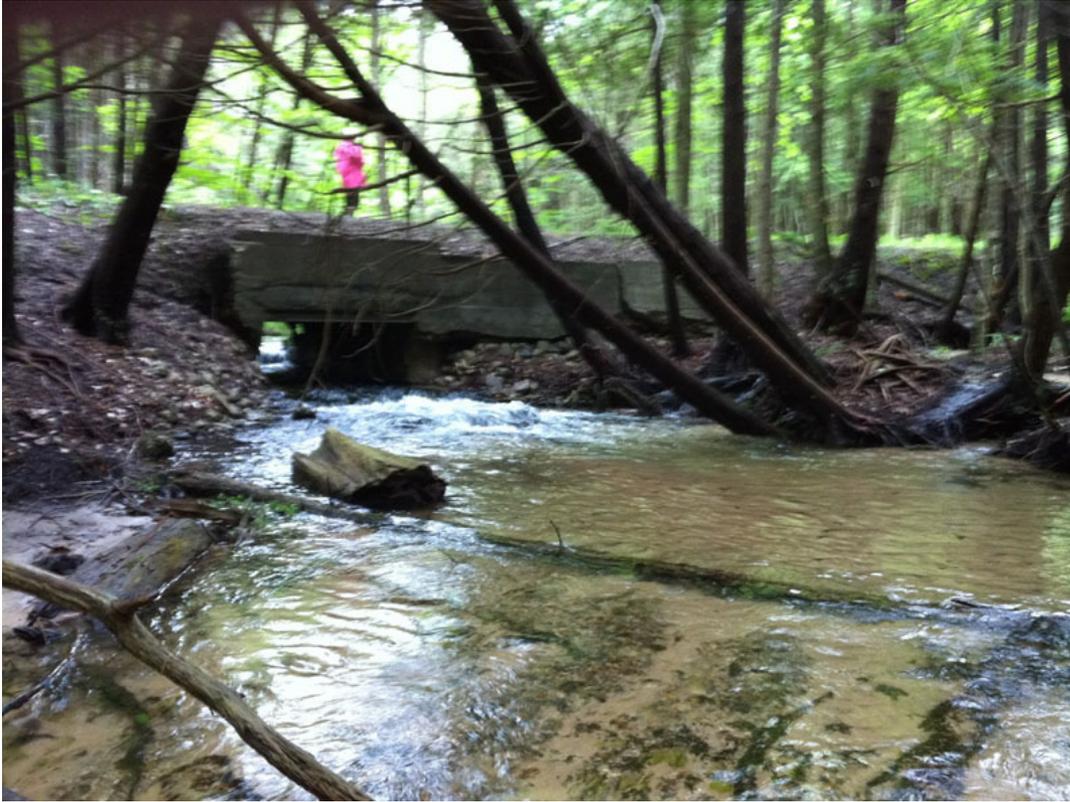
*Aging concrete bridge over Shanty Creek on Creekside Drive.*

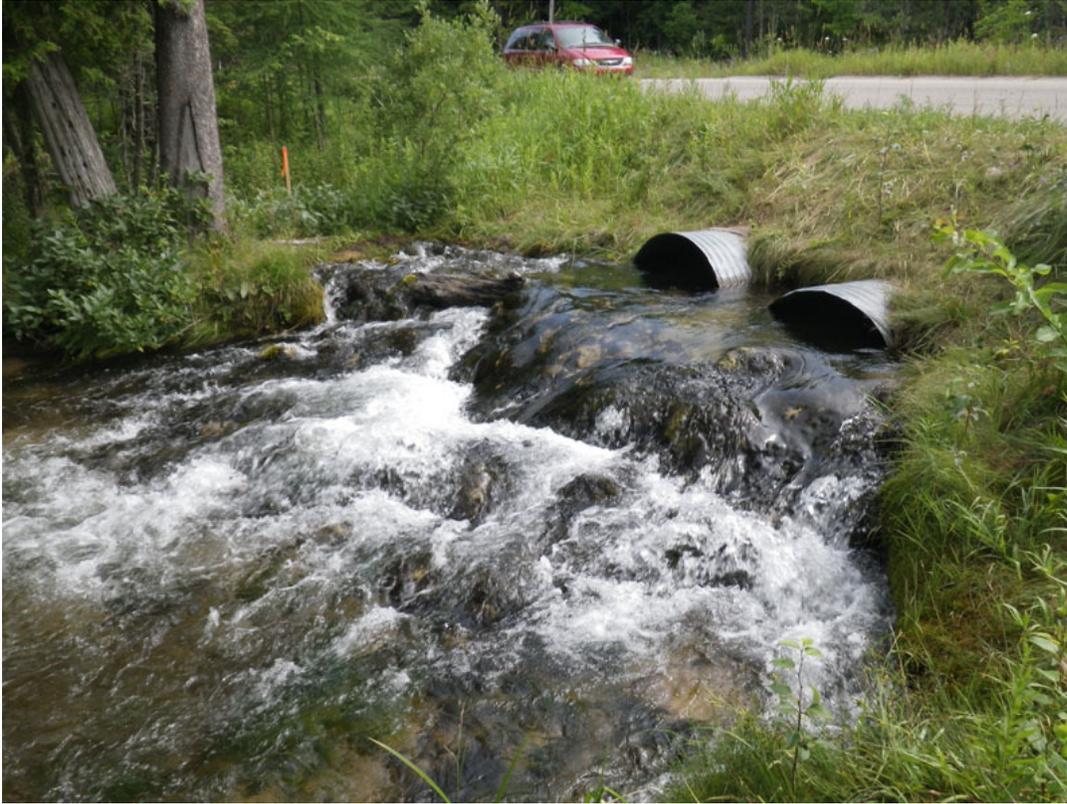
*Cascade over riprap at Finch Creek Road creates aquatic species passage barrier.*

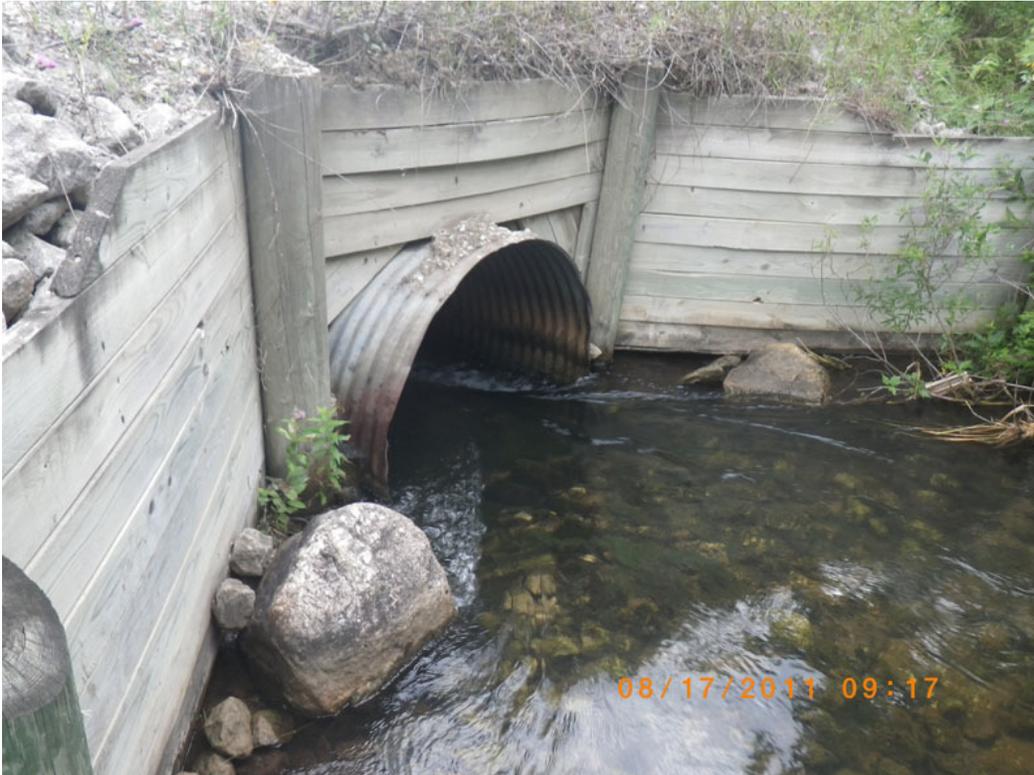
*Sediments fall on to the culvert and into the Little Rapid River at Hill Road.*

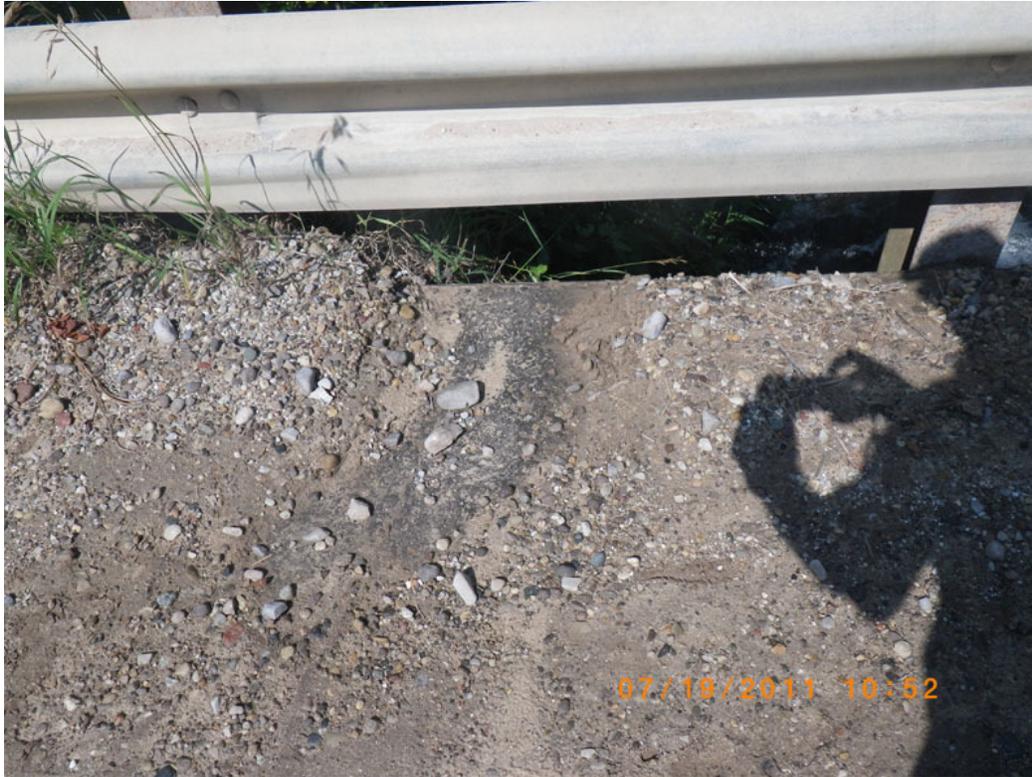
*Sediments pour into the Rapid River from the bridge at Dundas Road.*

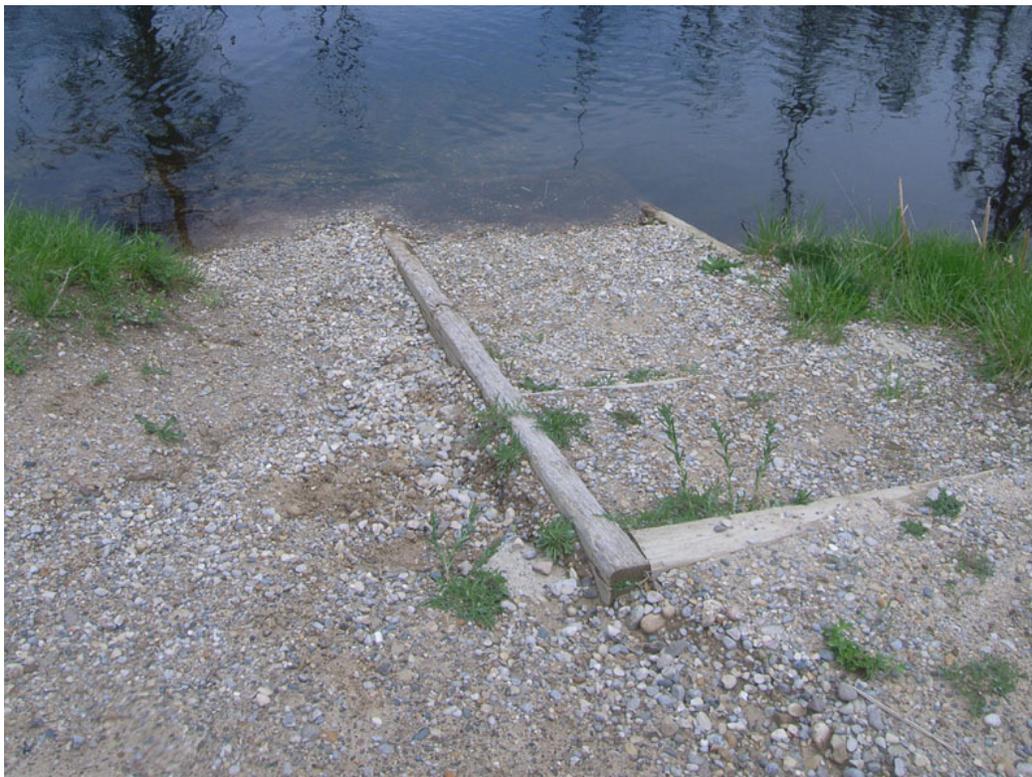
*Sediments wash into the Little Rapid River at access point on Old M72.*

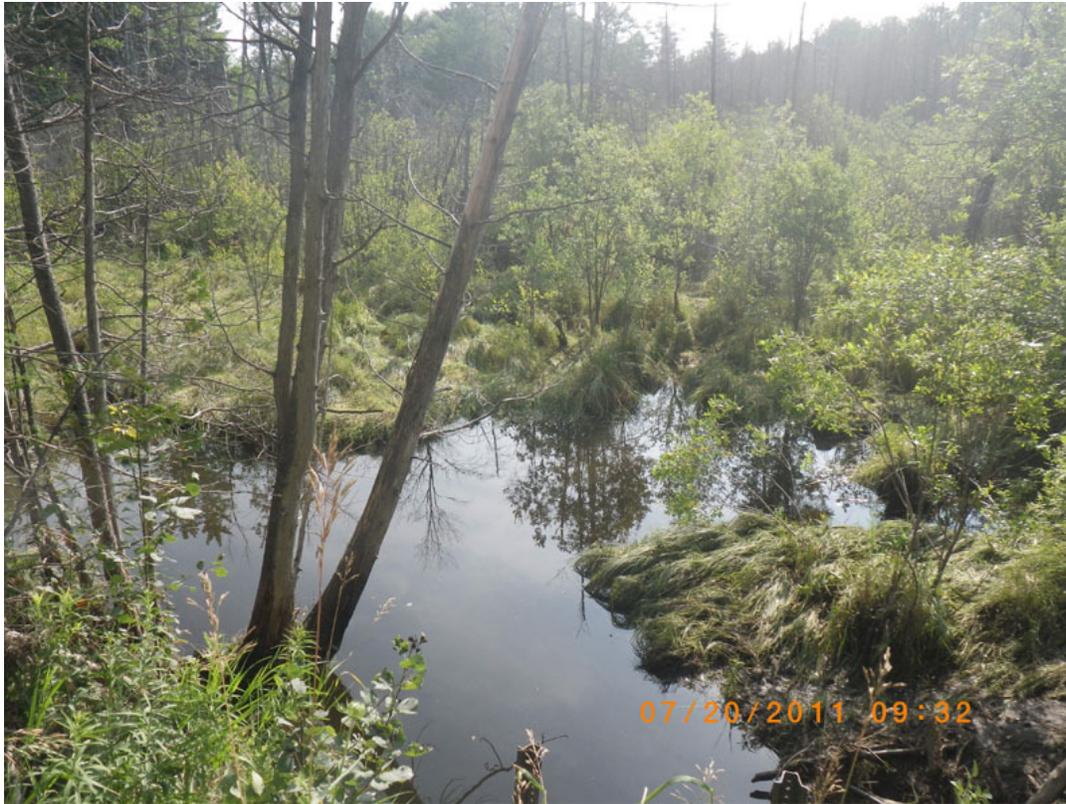
*Water ponds upstream of undersized culvert at Priest Road in the headwaters.*

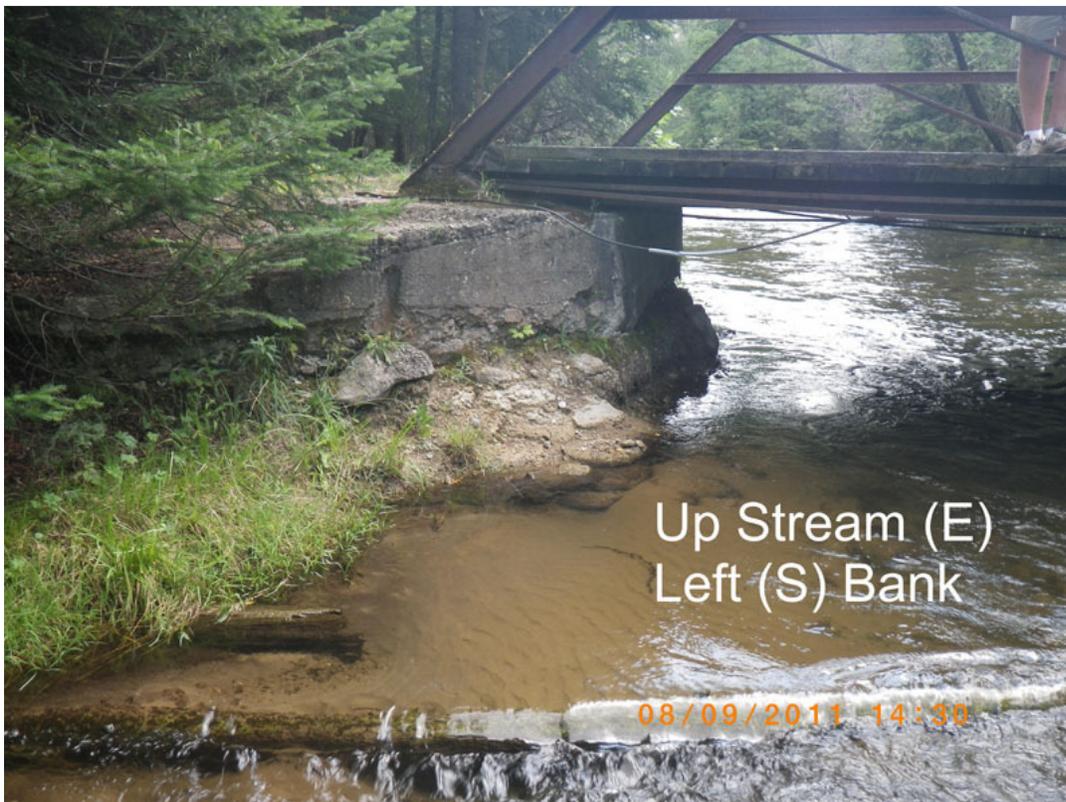
*Dilapidated bridge over the Rapid River at Glade Valley Road.*
