Ben-way Lake Shoreline Survey 2016

By Tip of the Mitt Watershed Council

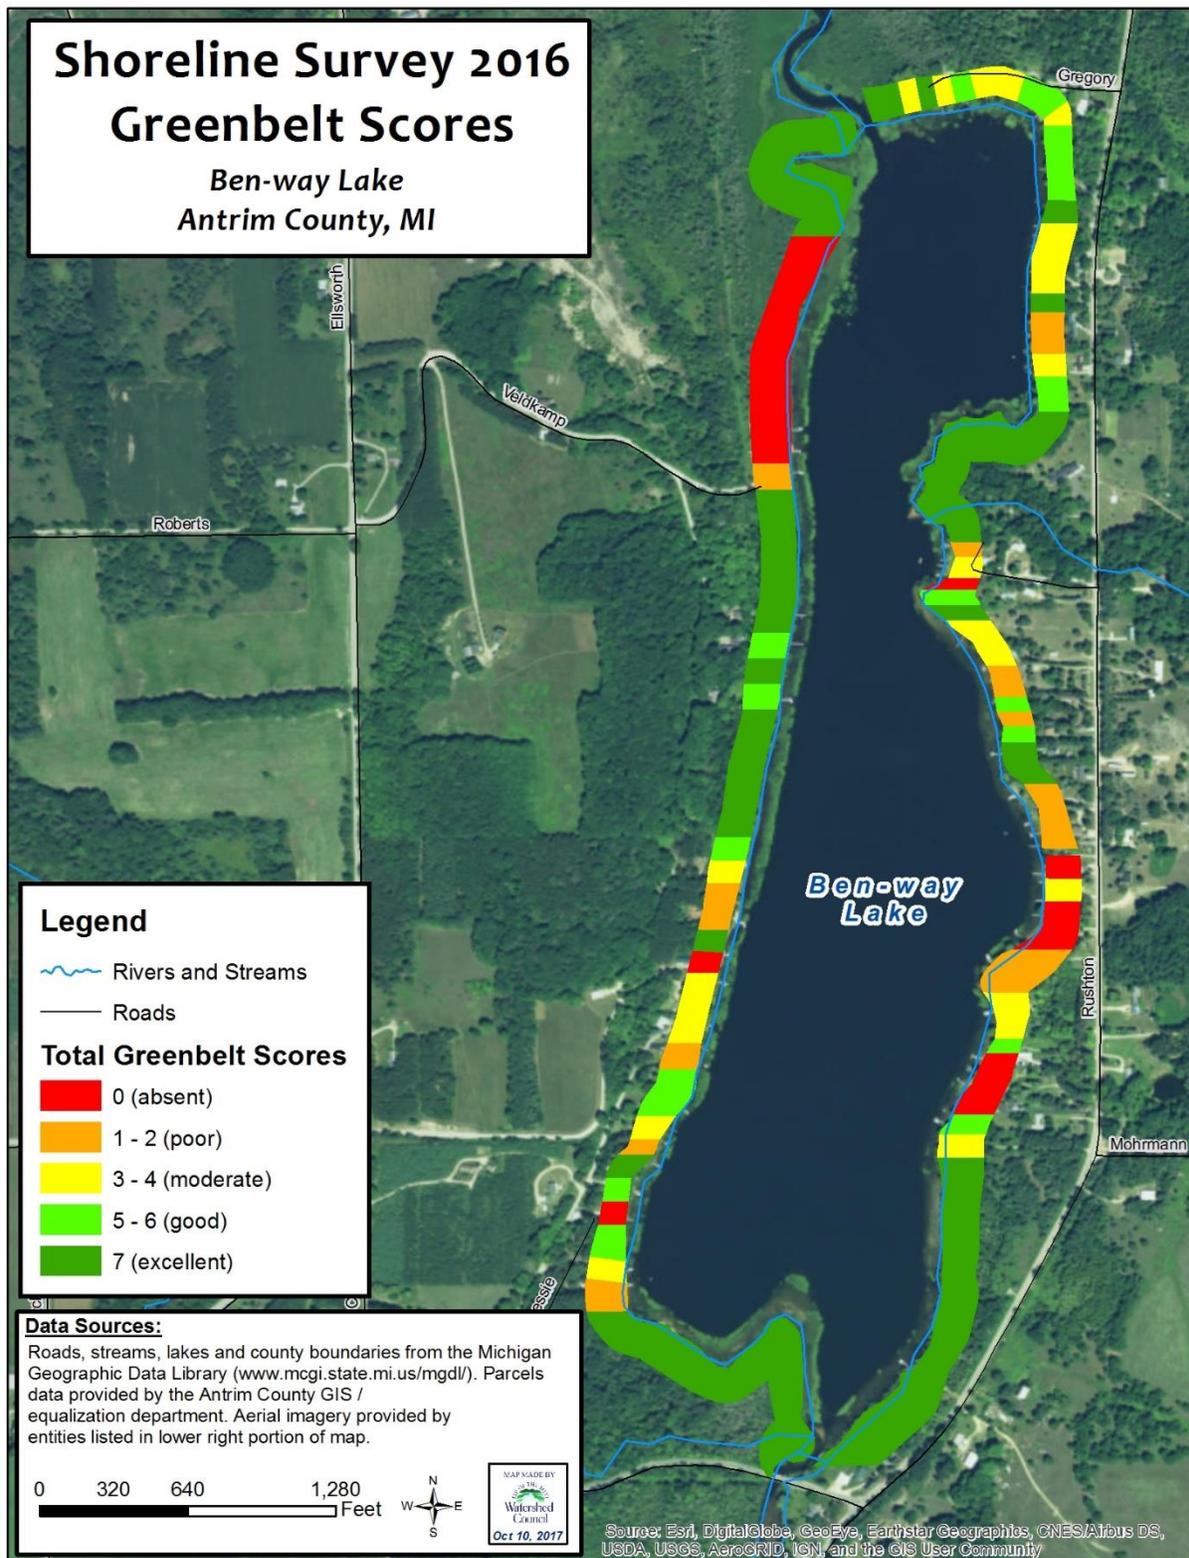
Figure 5. Greenbelt score totals results for Ben-way Lake.

Greenbelt scores ranged from 0 (little to no greenbelt) to 7 (exemplary greenbelt). Roughly half of greenbelts (48%) along the Ben-way Lake shoreline were found to be in good or excellent condition (Table 4). A nearly equal number of parcels (47%) received a greenbelt rating in the poor or very poor categories.

Greenbelt status ranged, in general, from high quality in the northern and southern ends of Ben-way Lake to poor mid-lake (Figure 5). Although clusters of properties with poor greenbelts occurred throughout the lake, they are more prevalent along the eastern shoreline. Large natural areas surrounding the inlet and outlet channels give way to light-moderate development along much of Ben-way Lake itself.

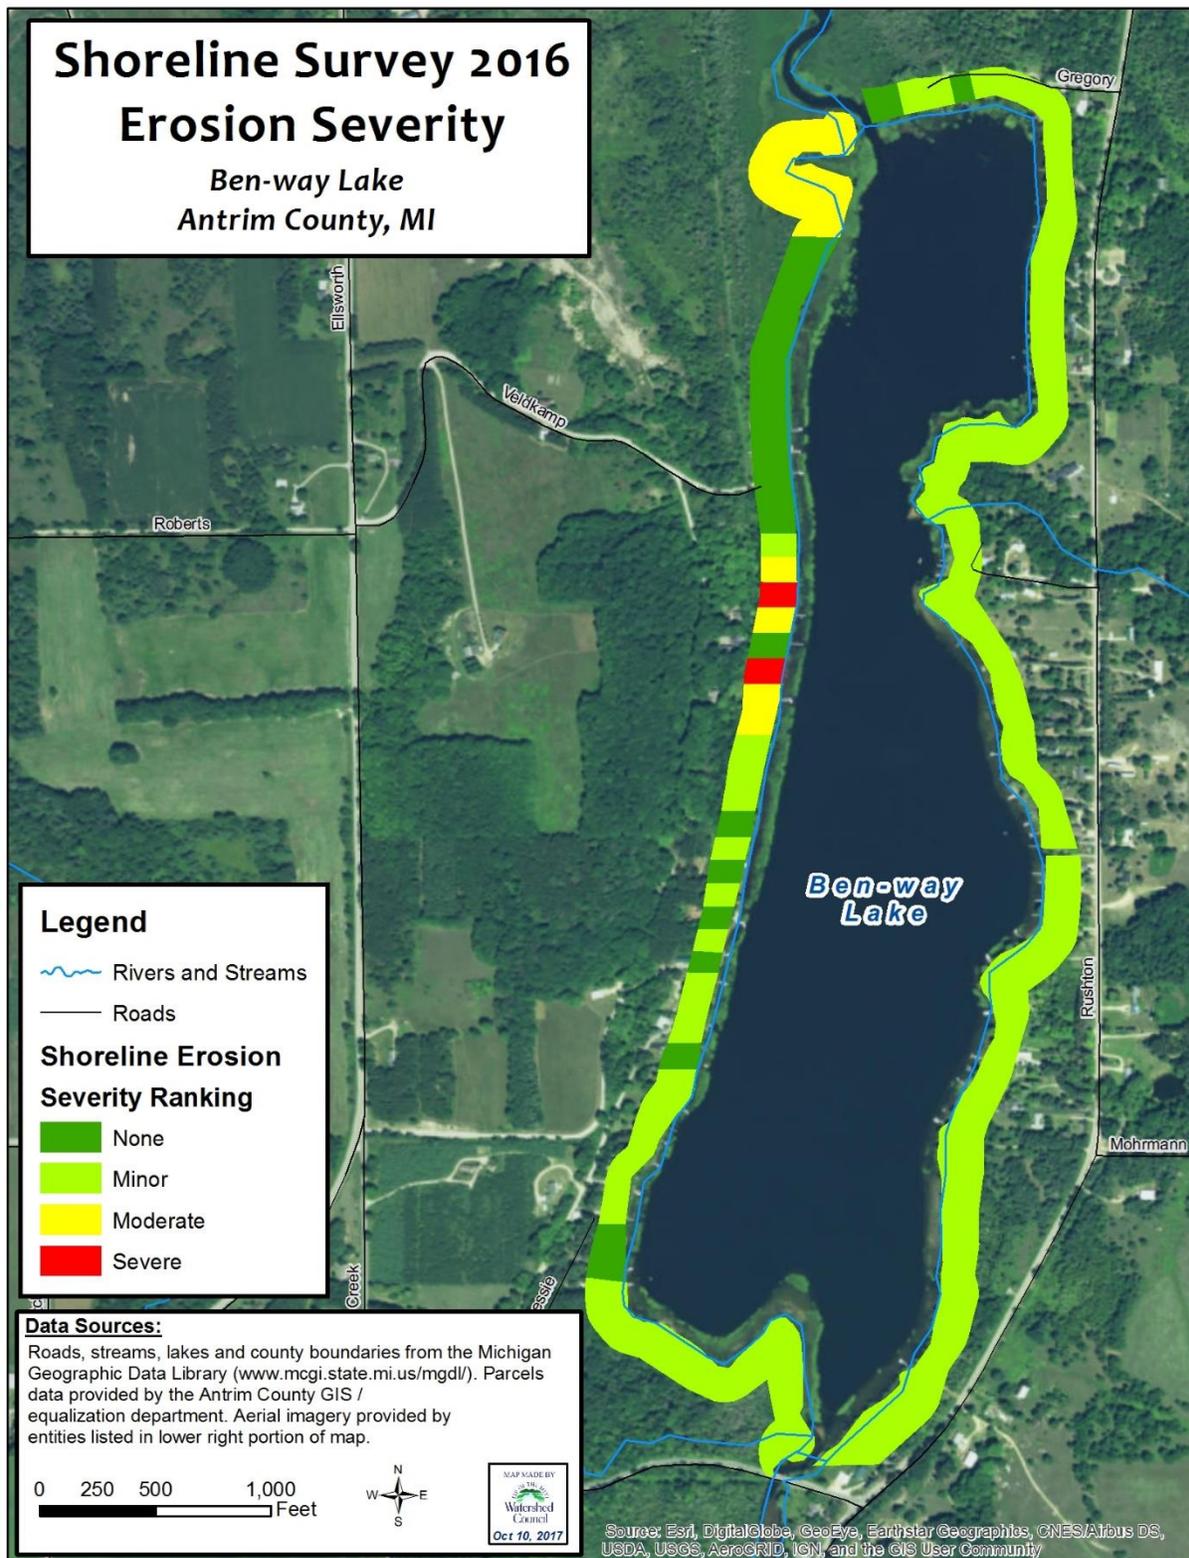
Figure 6. Shoreline erosion severity results for Ben-way Lake.

Erosion was noted at 74 parcels (84%) on the Ben-way Lake shoreline (Table 6). 92% of shoreline properties with erosion were classified as minor in terms of severity, while roughly 1% of properties were considered severe.

The entire eastern shoreline exhibited minor erosion. The most severe cluster of shoreline erosion was located mid-lake, at the most narrow point (east to west) in the Lake (Figure 6).

Although many properties on Ben-way Lake are experiencing some form of erosion, the majority (92% of all erosion sites) are considered minor and only 1% of all erosion is considered to be severe. Many properties with patches of lawn at water's edge experience a minor undercutting caused by waves and ice shove. Properties with artificial beach sand usually experience some loss of sand into the lake, evidenced by small erosional rills leading into the lake. Although not catastrophic, these types of minor erosion do have the ability to degrade the water and habitat quality of Ben-way Lake. In addition, the wake from large boats may be exacerbating erosion as unnaturally large waves break along the shoreline. The narrow point at the middle of Ben-way Lake has the most severe erosion, and is also a bottleneck for boat traffic. The proximity of boat operation to the shoreline in this area may be contributing to the erosion.
