Clam Lake Shoreline Survey Greenbelt Report

Friends of Clam Lake
And
Three Lakes Association

January 25, 2009

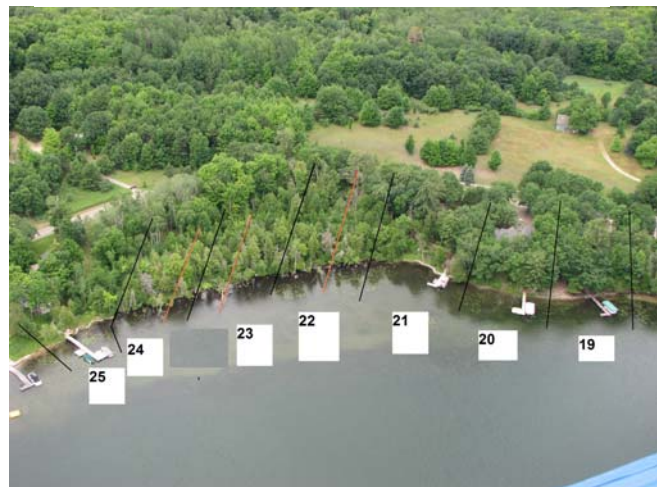
Figure 2 - Sample Shoreline Aerial Photo

For the Clam Lake survey, the parcel maps were marked with a survey order number starting at the south side of Clam River at the Torch Lake entrance and sequentially numbered counterclockwise around the lake, ending at the north side of Clam River. (Figure 1) This survey order number facilitated matching map location, the associated photographs and property data contained on the spreadsheet. The need for a road survey was eliminated by taking aerial photographs of the entire shoreline. These digital images were then matched with the parcel map and marked with the corresponding survey order number, using photo editing software. (Figure 2)

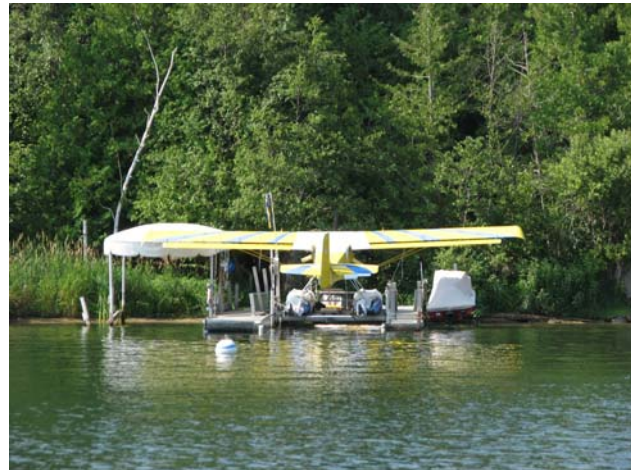
Figure 3 - Sample Shoreline Photo

Photographs were also taken from the water at the same time the survey observations were made. (Figure 3) The shoreline observations were from the high water mark back 25 feet. Thus, no data was taken on the number of boats, docks, rafts, and etc.
