Mullett Lake Partial Aquatic Plant Survey 2015

Pigeon River Bay, Aloha State Park, Mullett Lake Marina, and Mullett Creek Bay

*Survey and report by Kevin L. Cronk,
Daniel T.L. Myers, and Matthew L.
Claucherty.*

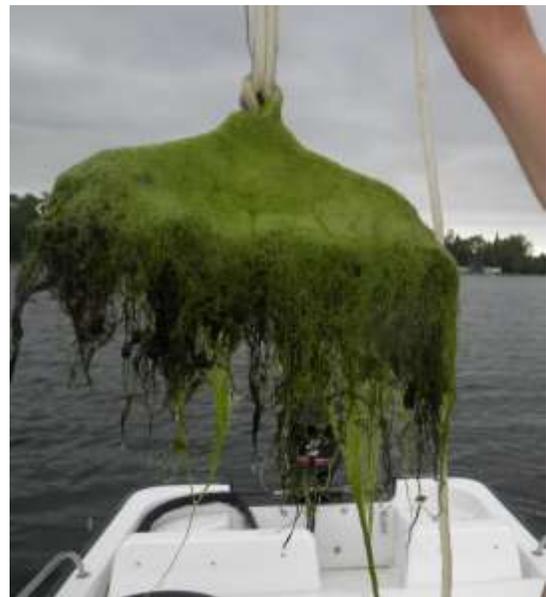
Significant algae growth was documented throughout Pigeon River Bay, often covering aquatic plants in a filamentous green slime (Figure 1). This algae indicates that nutrient pollution is still a concern in the Bay. Apparent cutting of plants in Pigeon River Bay was also noted

Figure 1. Algae covering aquatic plant sampling device in Pigeon River Bay.

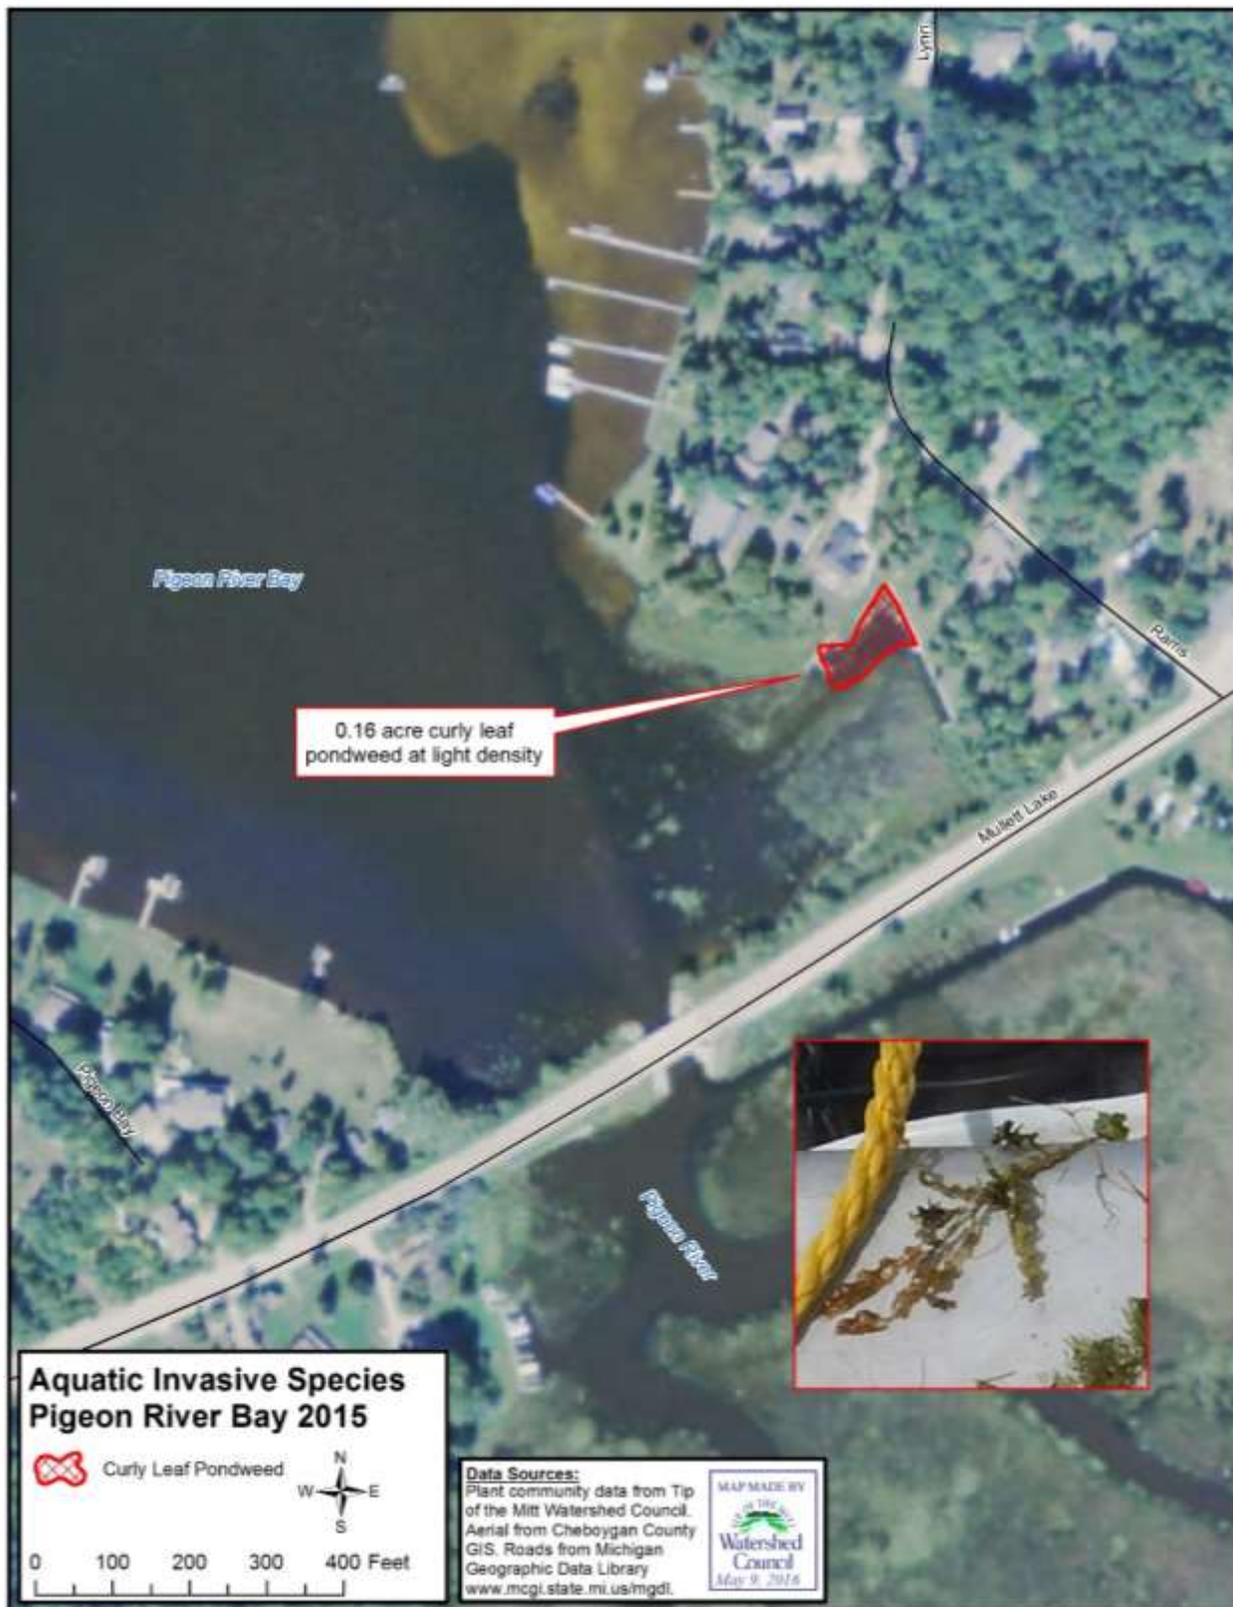
Approximately one sixth acre of curly leaf pondweed was documented in the southeast corner of Pigeon River Bay (Figure 4). This curly leaf pondweed infestation is interspersed with other plants and at light density.

Figure 4. Aquatic invasive plants of Pigeon River Bay.

4. Control invasive species. This survey documented aquatic invasive plant infestations in Pigeon River Bay, Aloha State Park, Mullett Lake Marina, and Mullett Creek Bay. Due to these plants' history of outcompeting native vegetation and becoming a nuisance in other lakes, MAPS should implement control efforts as soon as possible. Early detection and rapid response are critical for effective control, while also economically efficient and inflicting relatively little collateral damage to native species. Known infestations should be revisited frequently to assess efforts and continue with treatment as necessary.

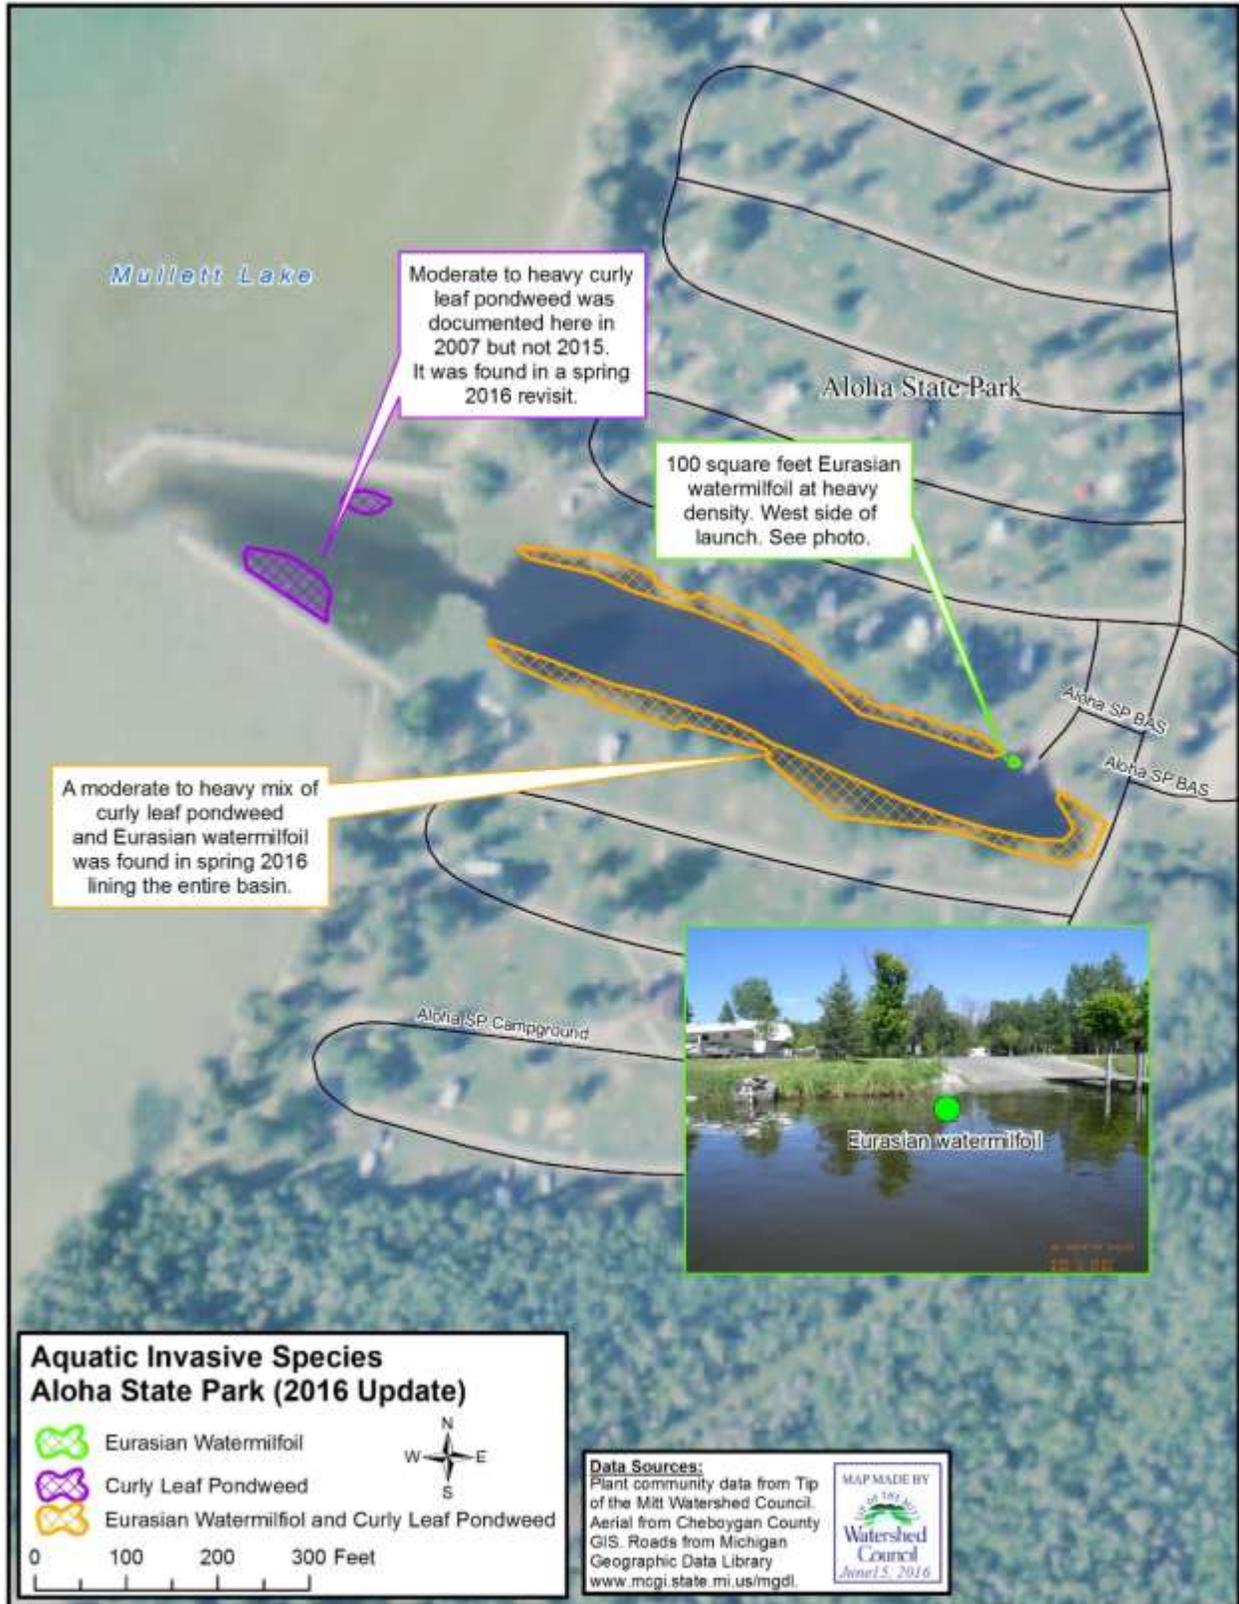
A 100 square foot patch of Eurasian watermilfoil was documented at the Aloha State Park boat launch in 2015 (Figure 7). Curly leaf pondweed and larger infestations of Eurasian watermilfoil weren't found during the 2015 survey, but their existence was confirmed during 2016 follow up. About half an acre (0.62 acres) of Eurasian watermilfoil and curly leaf pondweed mix was documented in the Aloha State Park marina during the follow up. An additional 0.1 acres of curly leaf pondweed mixed with other vegetation was documented by the marina breakwalls.

Figure 7. Aquatic invasive plants of Aloha State Park.

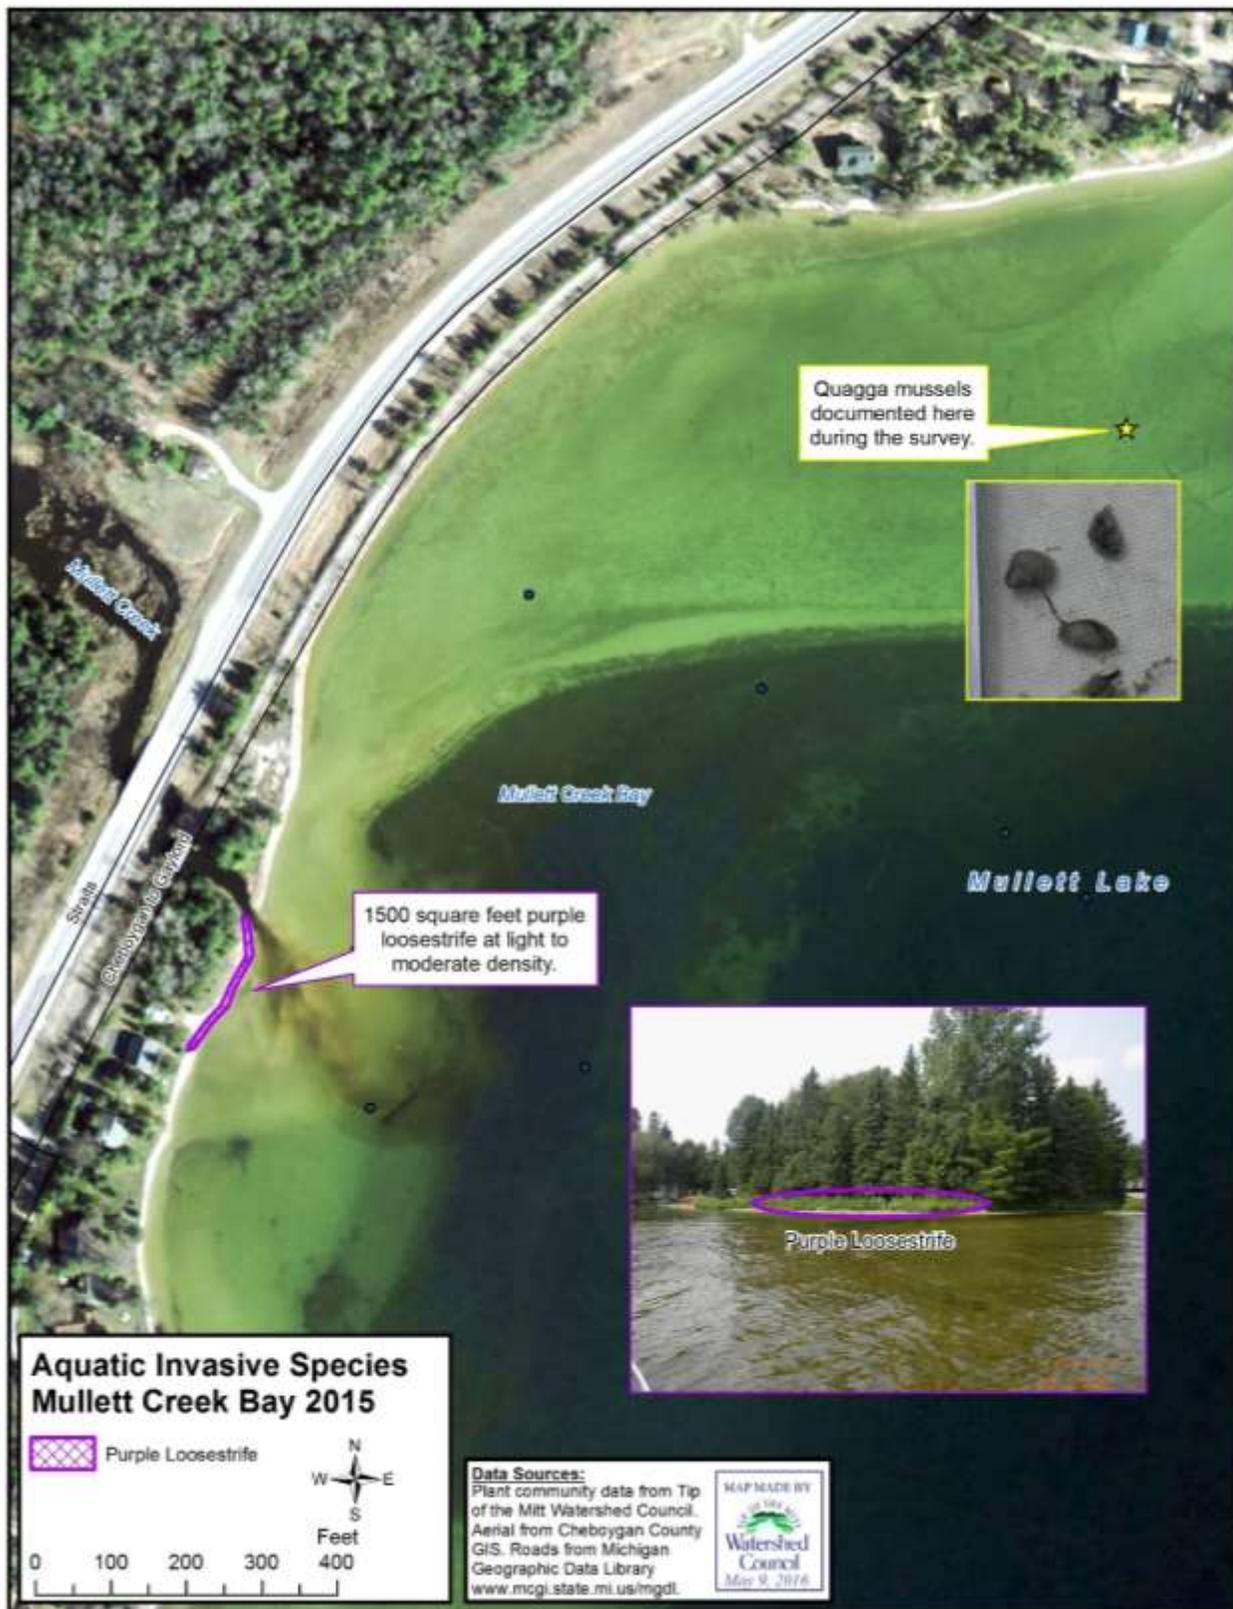
A small patch of purple loosestrife, approximately 1500 square feet, was documented south of the Mullett Creek mouth at light-moderate density (Figure 13). As a side note, invasive quagga mussels were also documented at one site in Mullett Creek Bay during the survey.

Figure 13. Aquatic invasive plants of Mullett Creek Bay.
