Thayer Lake Shoreline Survey 2017

By Tip of the Mitt Watershed Council

Data collected by Watershed Protection Team 2017

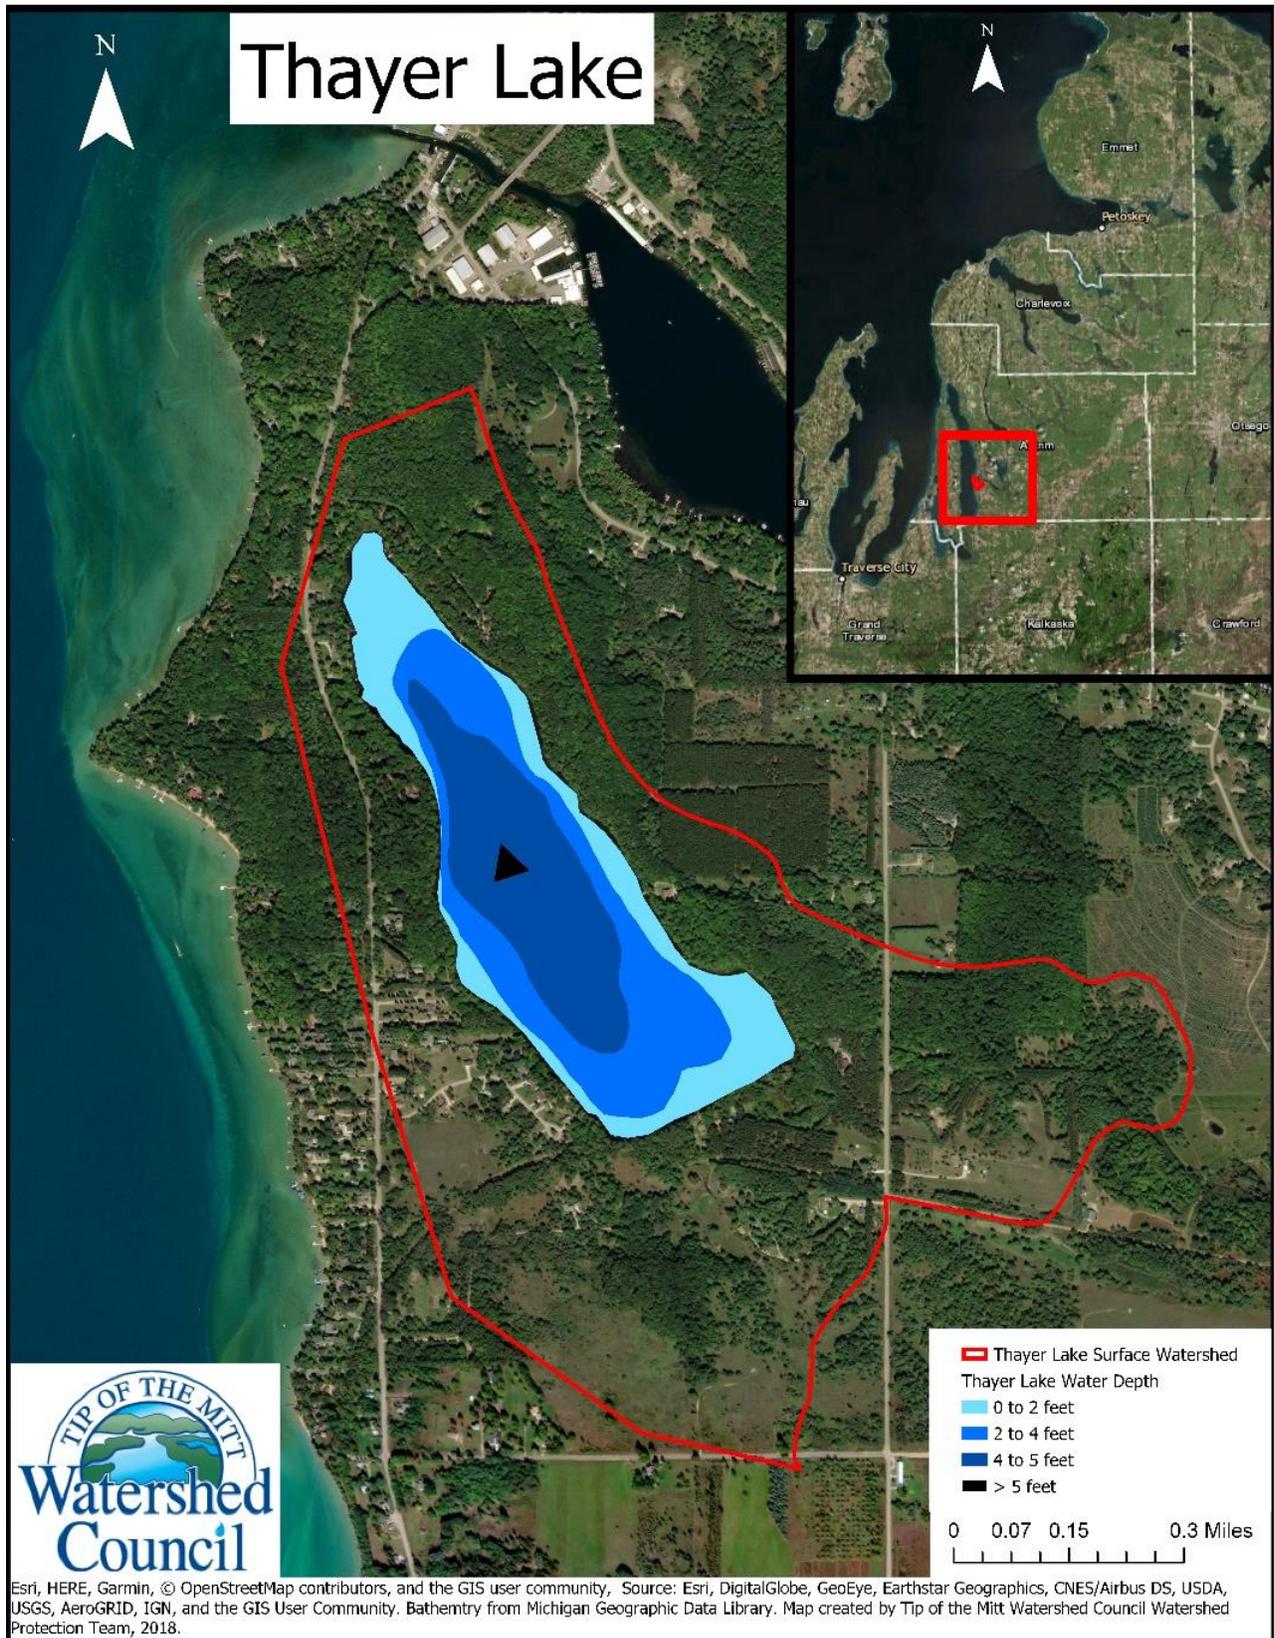
Figure 1 Map of Thayer Lake Depths (bathymetry) and surface watershed.

Located in the northwestern area of the Lower Peninsula, Thayer Lake resides in central Antrim County. Thayer Lake has a surface area of just 106 acres and a shoreline length of 2.1 miles. A unique aspect of Thayer Lake is there are no primary tributaries flowing into the lake. Thayer Lake is known as a seepage lake. The primary inflow and outflow from the lake is via nearby surface runoff and groundwater flow. According to digitized bathymetry maps acquired from the Michigan Geographic Data Library, the deepest area of Thayer Lake is located near the center, reaching 18 feet in depth (Figure 1).

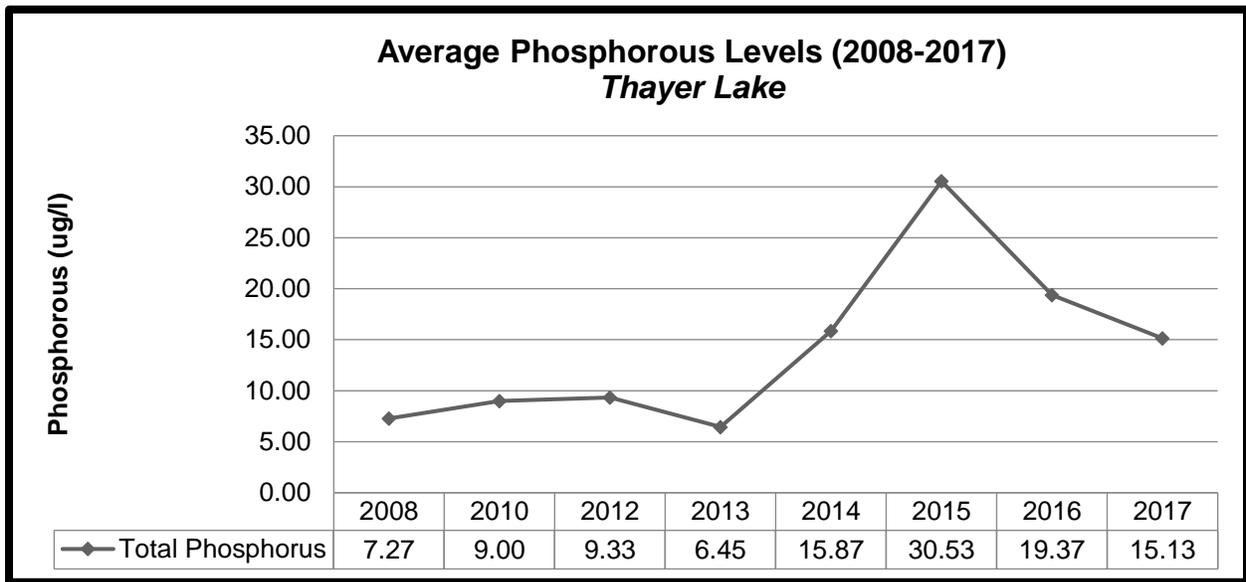
Figure 2 Thayer Lake Total Phosphorus Trends from 2008 through 2017

From these programs, data indicate Thayer Lake water quality is relatively good. Total phosphorous measurements show concentrations spiked in 2014-2015 (Figure 2) while nitrogen has decreased slightly, ranging between 420 – 660 µg/L (Figure 3). Chloride has remained around the 8.0mg/L and was slightly lower in 2016 than 2013 (Figure 4).

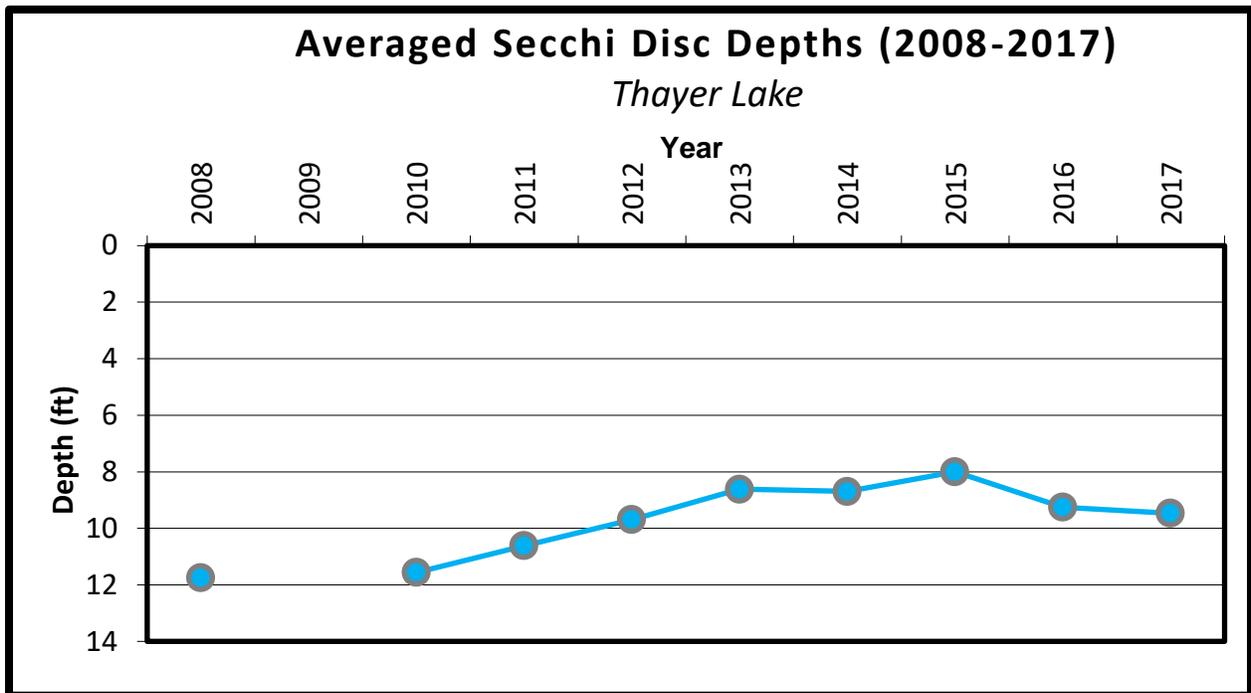
Figure 5 Average Secchi Disc depths collected by Thayer Lake Volunteers since 2008

Since 2008, local volunteers have ventured out to Thayer Lake to record Secchi disk depth, water temperature, and collect water samples for *chlorophyll-a* measurements. These data align with above nutrient data. Since 2008, Thayer Lake appears to have become slightly more turbid, with Secchi disk readings decreasing from 12ft. in 2008 to a little under 10ft. in 2017 (Figure 5). The lowest water clarity was documented in 2015, the same year phosphorus and *chlorophyll-a* measurements showed a spike in concentrations. At the end of each sampling year, a trophic status index (TSI) is calculated (Figure 7). This value is a measure of biological productivity in a lake at the time of Secchi disk and *chlorophyll-a* sampling. A TSI value ranges from 0 to 100, where a score below 38 describes a lake devoid of nutrients, low biological productivity, and very clear water. A TSI score of 39 – 49 indicates a mesotrophic lake system. Mesotrophic simply means the lake has a moderate amount of nutrients. When nutrients become a problem and productivity becomes too high, a lake is considered “eutrophic” (TSI value above 50). Thayer Lake has been in the mesotrophic category, with a TSI value ranging between 41 and 48.

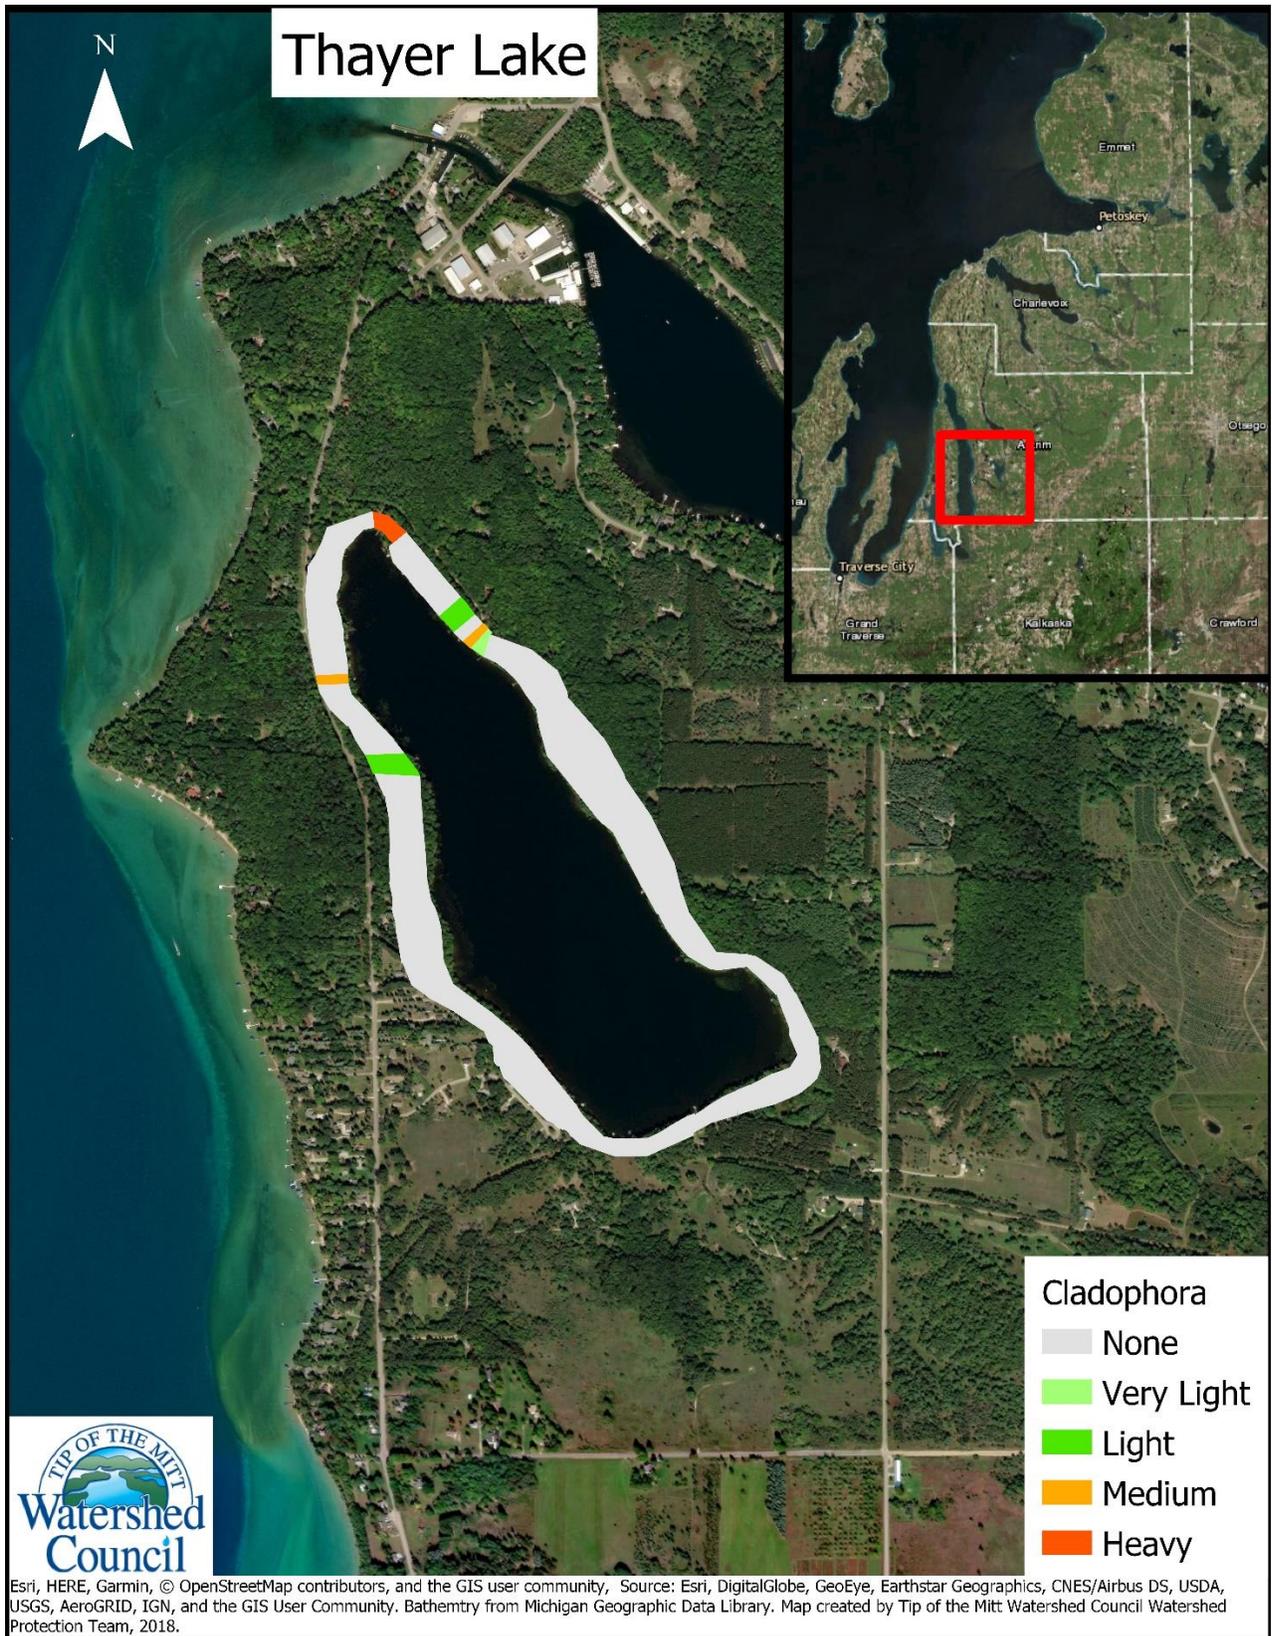
Figure 8 Cladophora density around Thayer Lake Shoreline

Noticeable growths of *Cladophora* or other filamentous green algae were found along the shoreline at 7 parcels (11% of total parcels surveyed; Table 3). At properties where *Cladophora* growth was observed, 4 parcels consisted of light or very light growth, while 3 parcels had moderate to heavy growth. The few patches of *Cladophora* growth were located along the Northern shores of Thayer Lake (Figure 8).

4. Inform owners of properties with heavy *Cladophora* growths of specific results for their property, ask them to fill out a questionnaire in an attempt to interpret causes of the growth, and offer individualized recommendations for water quality protection.

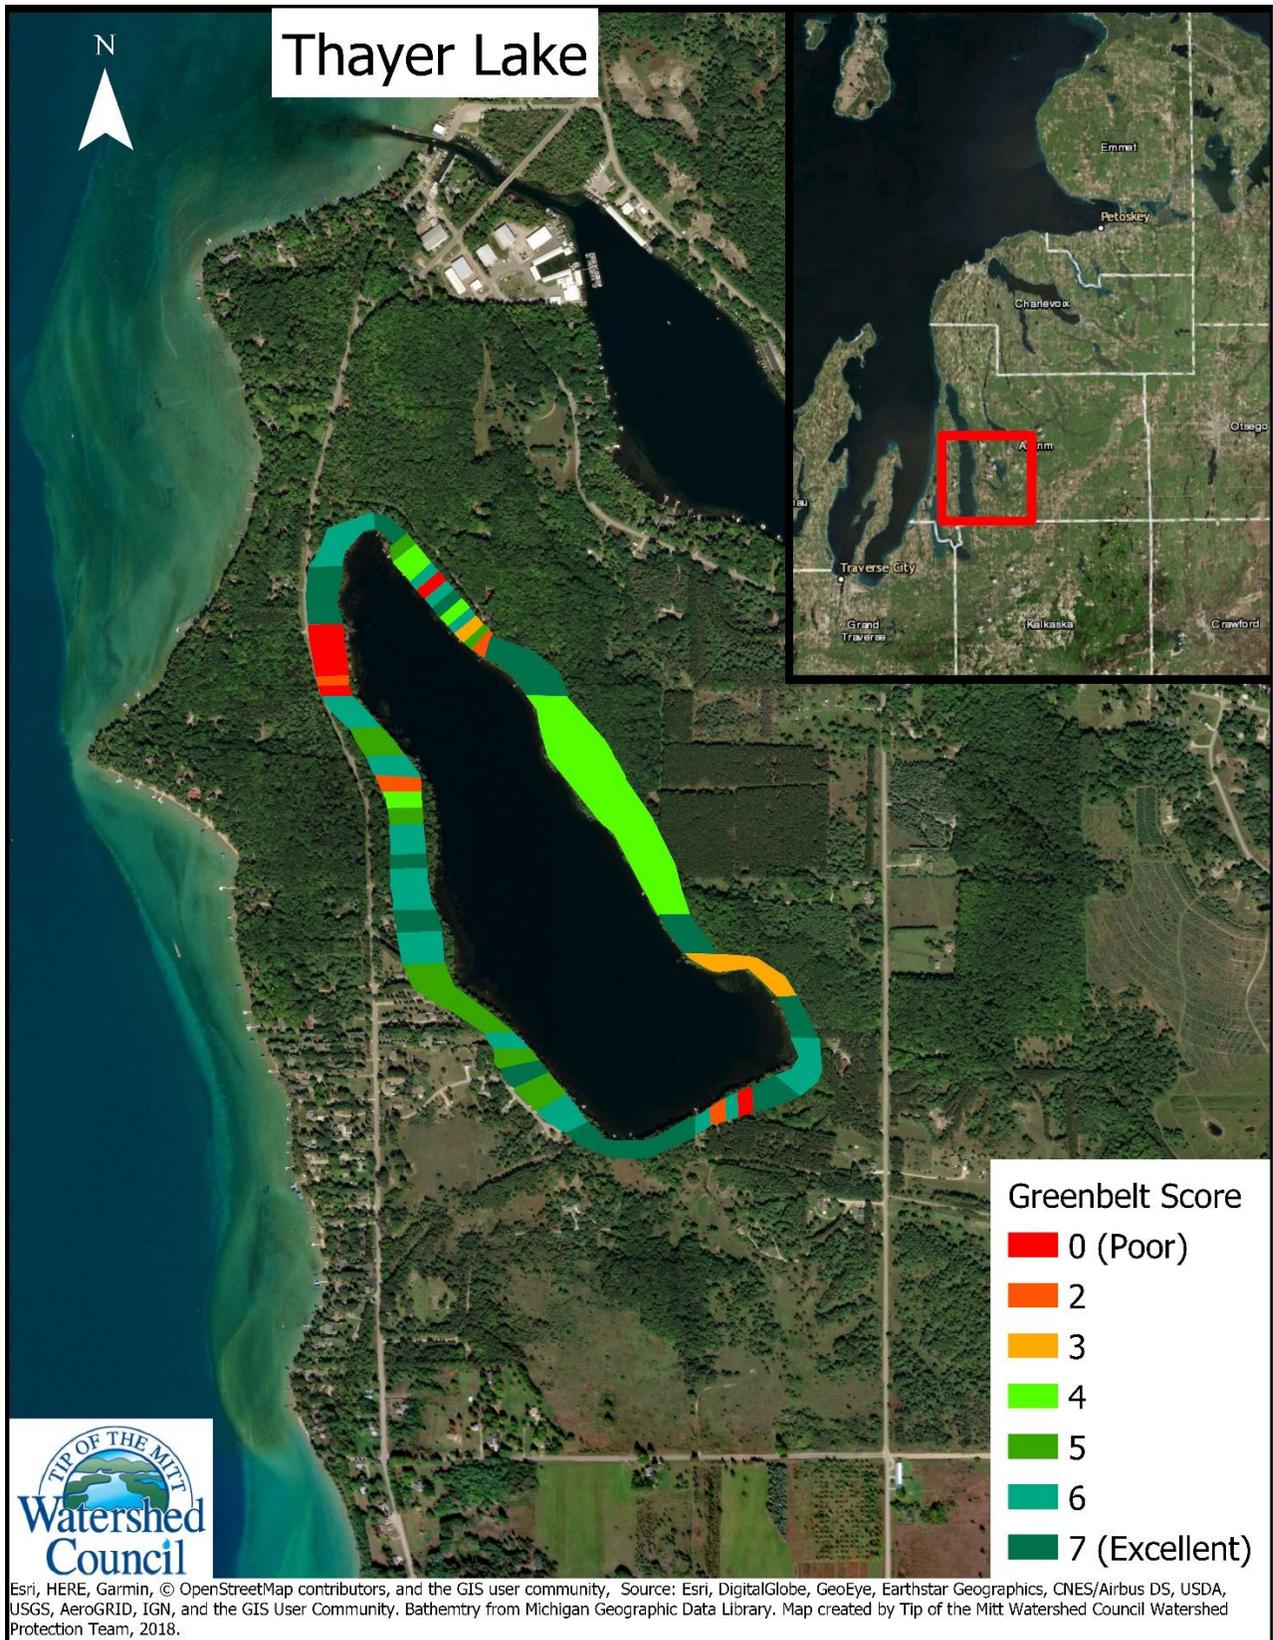
Figure 9 Greenbelt Scores around Thayer Lake shoreline

Greenbelt scores ranged from 0 (little to no greenbelt) to 7 (exemplary greenbelt). Thayer Lake greenbelts were generally observed to be in good or excellent condition (71%, table 4). Of 61 surveyed, 10 parcels (16%) received a greenbelt rating in the poor or very poor categories.

Greenbelt status varied around Thayer Lake. However, clusters of properties along the northern shoreline were ranked in the very poor (absent) to poor categories (Figure 9). Large parcels along the eastern shoreline showed good greenbelts while clusters along the western and southern shoreline were in the excellent rating.

5. Inform owners of properties with poor greenbelt scores and those with severely eroded shorelines of specific results for their property. Supply these property owners with

information (e.g., brochures) regarding the benefits of greenbelts and/or the problems associated with erosion. Encourage property owners to improve greenbelts using a mix of native plants and to correct erosion problems. Property owners can contact the Watershed Council for more information on how to improve greenbelts and/or correct erosion problems.

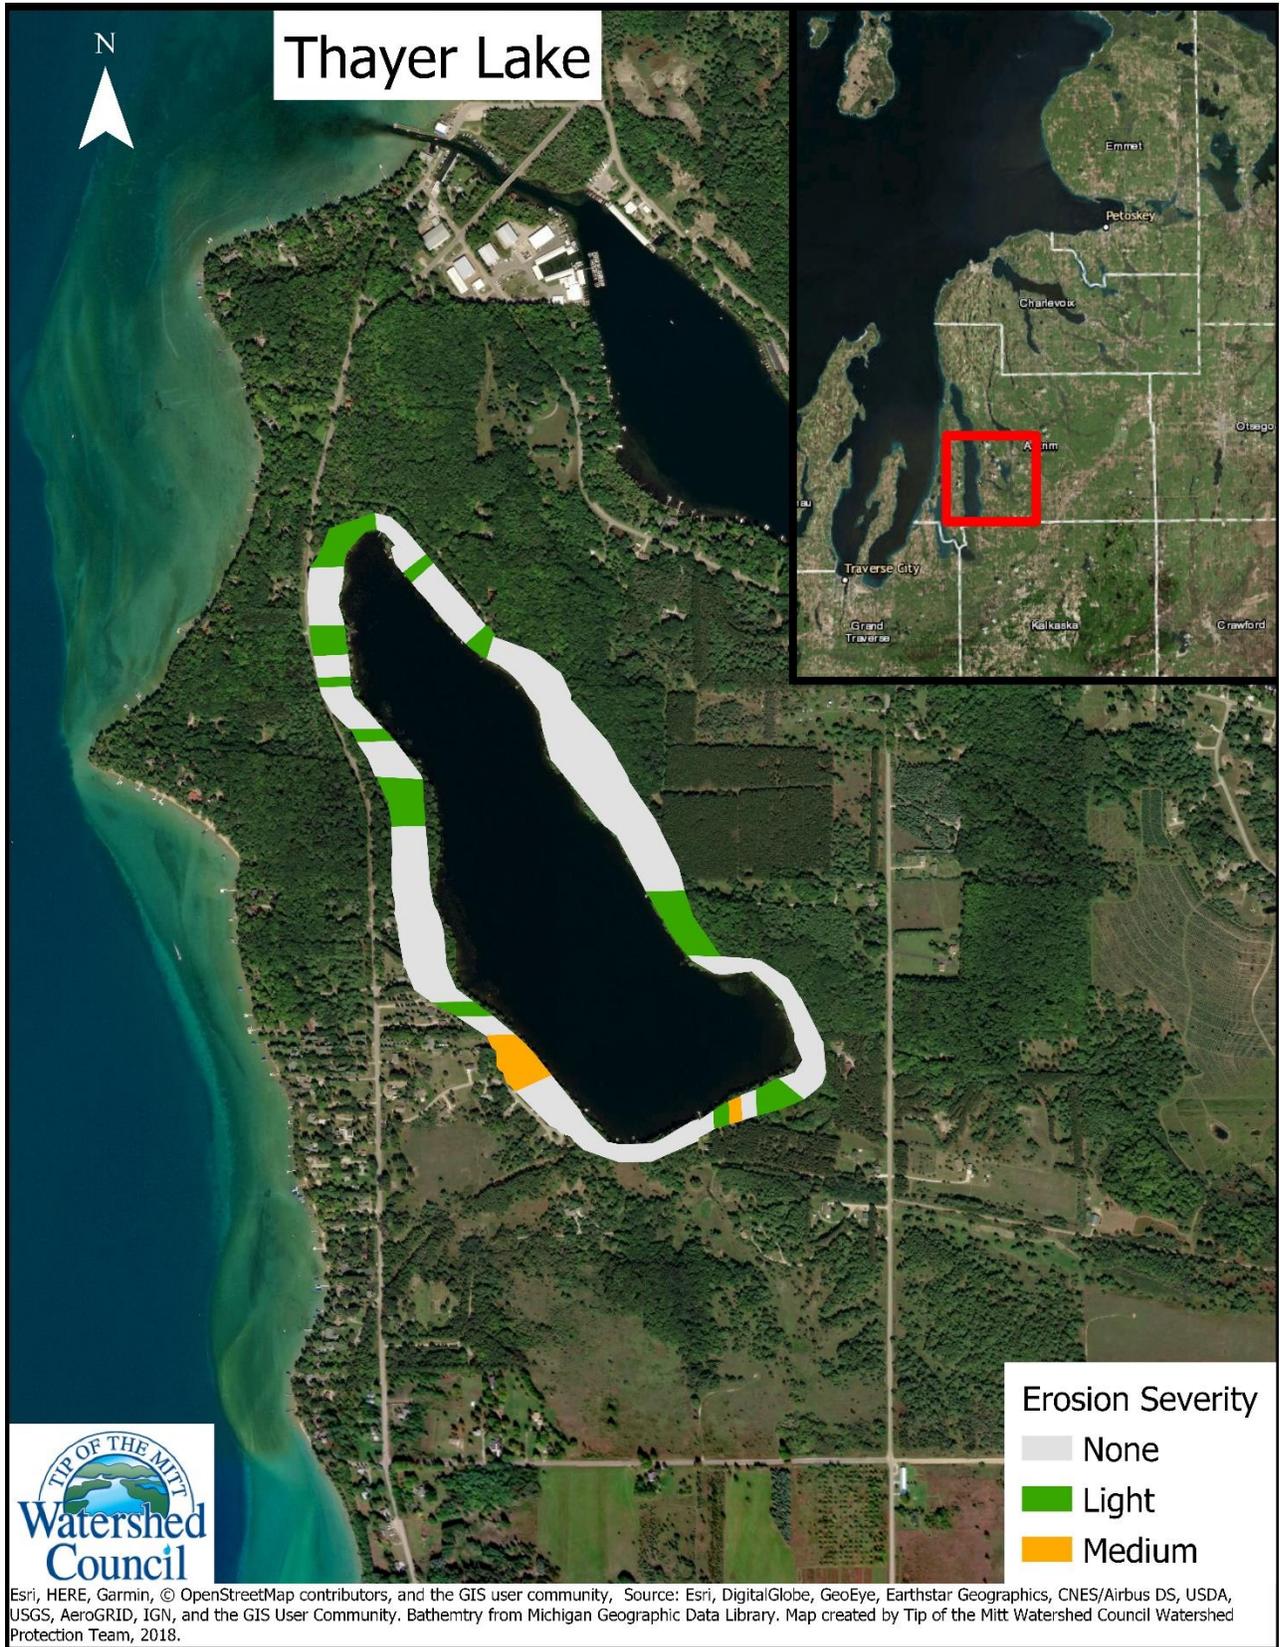
Figure 10 Erosion severity around Thayer Lake shoreline

Erosion was noted at 20 parcels (32%) on the Thayer Lake shoreline (Table 6). Most of the erosion (37%) was classified as minor in terms of severity, while less than 1% of properties were considered severe. (Figure 10).

Although many properties on Thayer Lake are experiencing some form of erosion, the majority (82% of all erosion sites) are considered minor and less than 3% of all erosion is considered to be severe. Many properties with patches of lawn at water's edge experience a minor undercutting caused by waves and ice shove. Properties with artificial beach sand usually experience some loss of sand into the Lake, evidenced by small erosional rills leading into the Lake. Although not catastrophic, these types of minor erosion do have the ability to degrade the water and habitat quality of Thayer Lake. To prevent changes to the lake ecosystem, changes should be made in shoreline property management. Mismanagement of shoreline properties can degrade the lake's water quality, diminish fisheries, and even create an environment that poses threats to human health. Therefore, Tip of the Mitt Watershed Council offers a number of recommendations.
