Clam Lake Shoreline Survey Greenbelt Report

Friends of Clam Lake
And
Three Lakes Association

January 25, 2009

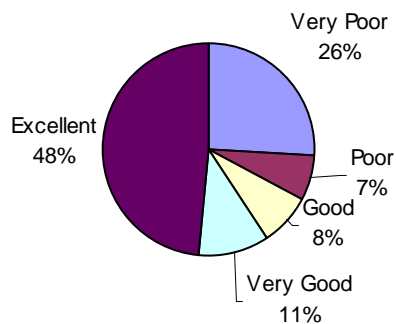
Graph #3 -- Clam Lake Shoreline Quality

The quality score is derived from the scoring numbers shown on the second page of the survey form. (Appendix A) This system is the same as that used on both Torch and Bellaire surveys.

Very Poor	(-9) to 0
Poor	1 to 4
Good	5 to 9
Very Good	10 to 14
Excellent	15 to 16

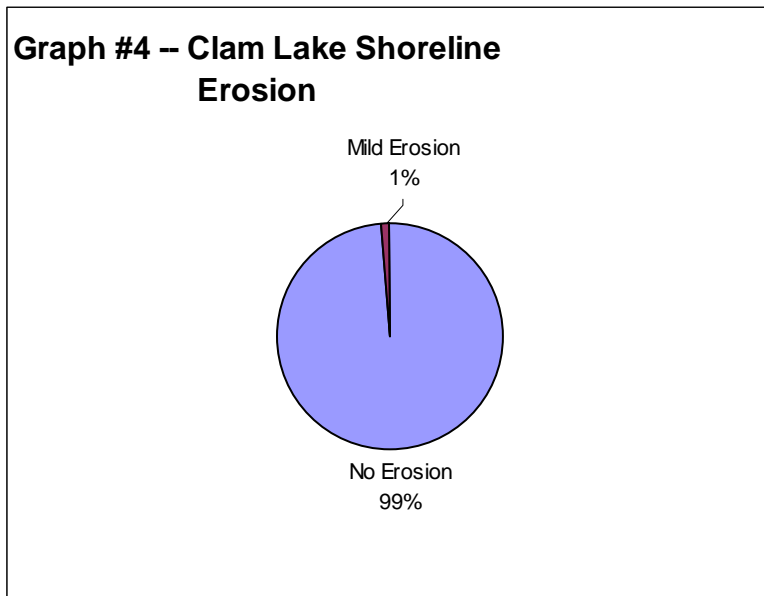
Table 4 and Graph 4 show the erosion status on the Clam Lake shoreline. Fortunately only 1% of the properties have mild erosion with no severe erosion problems.
