LAKE BELLAIRE SHORELINE SURVEY SUMMARY REPORT

Three Lakes Association
PO Box 689
Bellaire, MI 49615

by
William Bohannon,
Braden Ackerman,
Wilhelmina Witt
and
TLA Volunteers

August 30, 2008

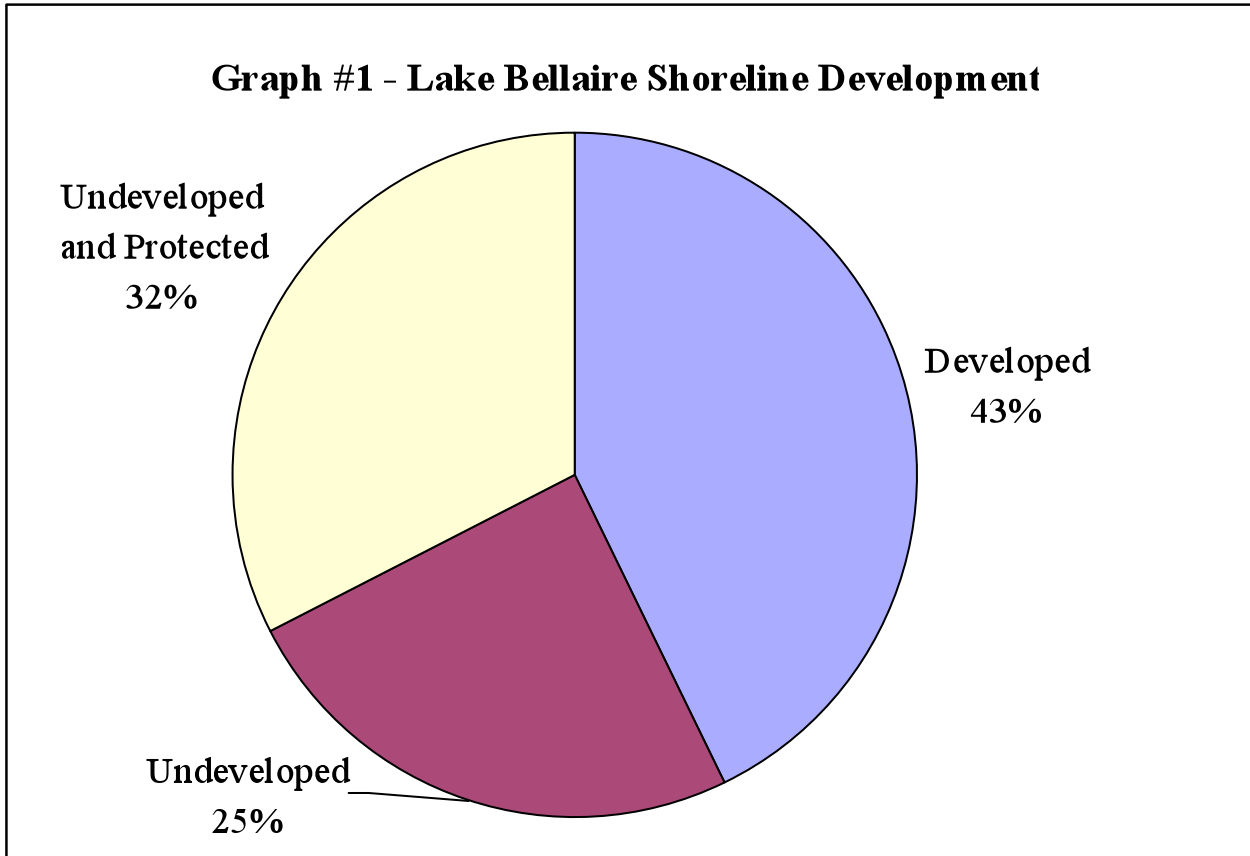
**Lake Bellaire Shoreline Development
by Township**

Devel.			Prot. and Undevel.			Undevel			Tot. Ft.
	Parcels	Feet	Percent	Parcels	Feet	Percent	Parcels	Feet	Percent	
Forest Home	157	19,076	39%	13	16,662	34%	71	12,764	26%	48,502
Kearney	29	3,136	74%	2	970	23%	3	133	26%	3,269
Custer	12	1,590	57%	0	0	0%	6	1,185	50%	2,774
Total	198	23,802		15	17,632		80	14,082		54,545

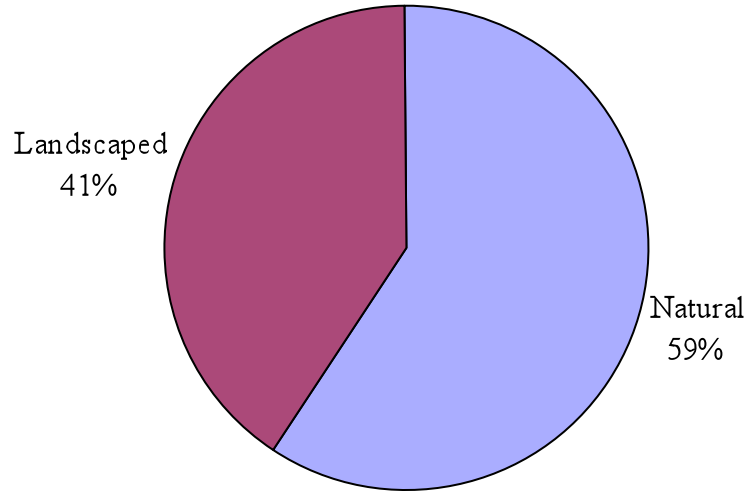
**Graph #2 - Lake Bellaire Shoreline Condition
Landscaped or Natural**

Landscaped			Natural			
	Parcels	Frontage Feet	Percentage	Parcels	Frontage Feet	Percentage	Total Feet
Forest Home	146	17,364	36%	95	31,139	64%	48,502
Kearney	30	3,362	79%	4	877	21%	4,239
Custer	13	2,110	66%	5	1,085	34%	3,194
Total	189	22,835	41%	104	33,100	59%	55,936

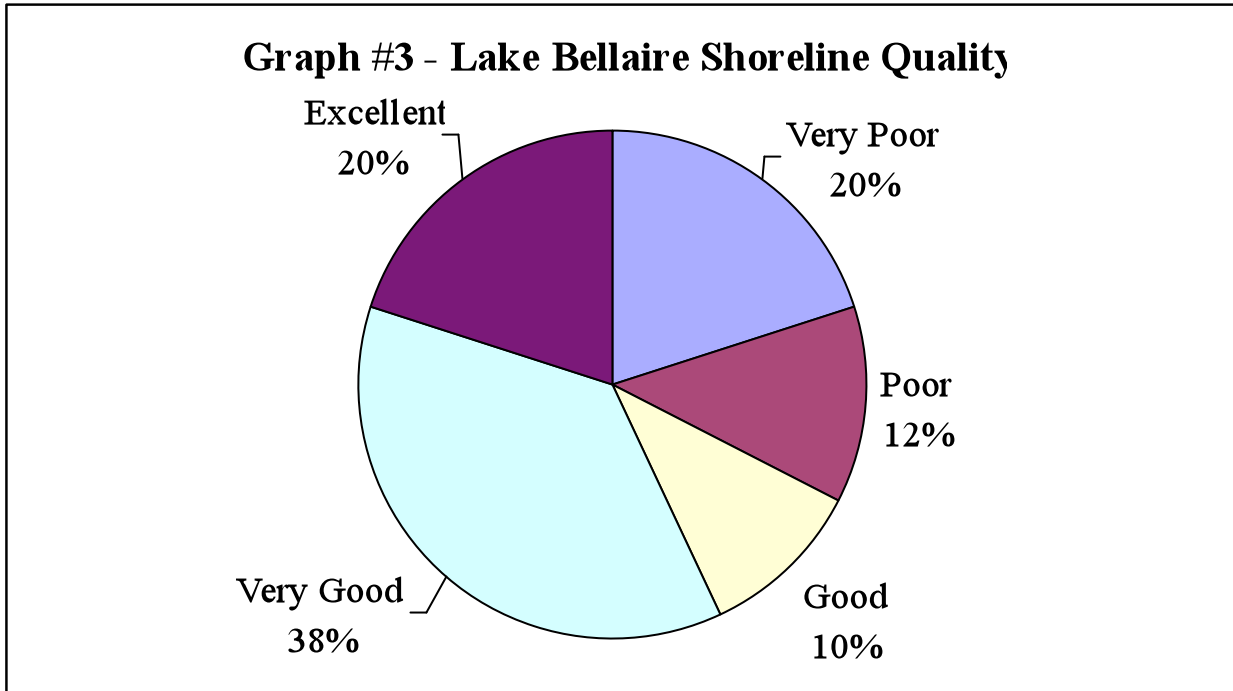
**Lake Bellaire Shoreline Quality
by Township**

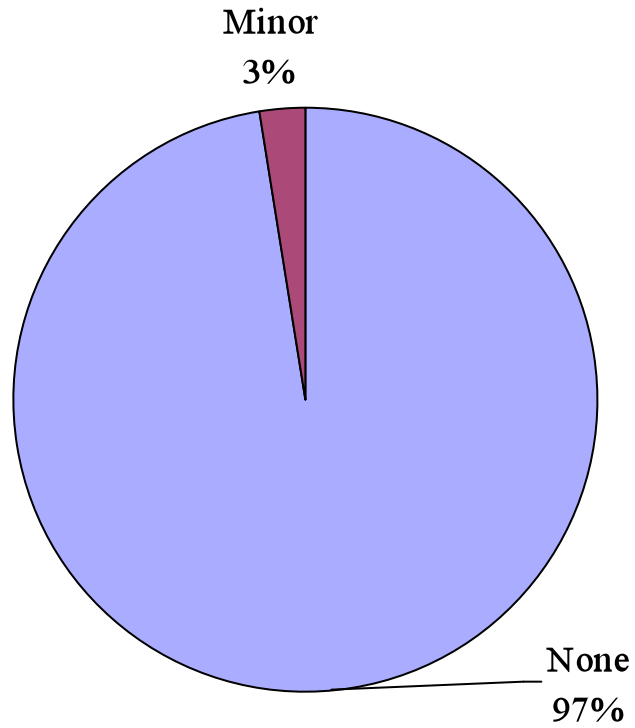
Graph #4 - Lake Bellaire Shoreline Erosion

Lake Bellaire Shoreline Erosion by Township

3. Public and private property owners should restore erosion sites.
4. Because the Northwest Michigan Community Health Agency Unified Sanitary Code does not regulate failing septic systems, a Point of Sale Inspection Ordinance for all septic systems around the lake should be created.
5. There needs to be an educational program to inform property owners about the best practices for protecting water quality.
