**Walloon Lake Dam and Fish Grate  
Historical Review and Recommendations**

**Tip of the Mitt Watershed Council**

**November, 1994**

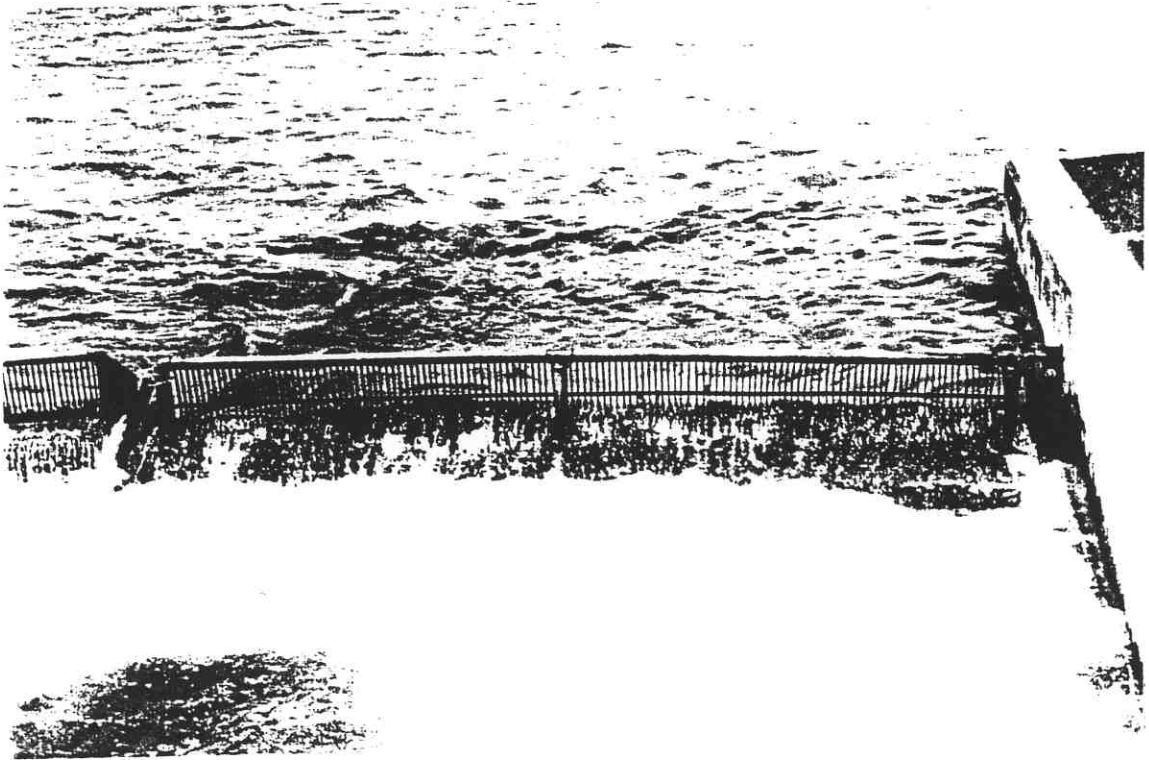
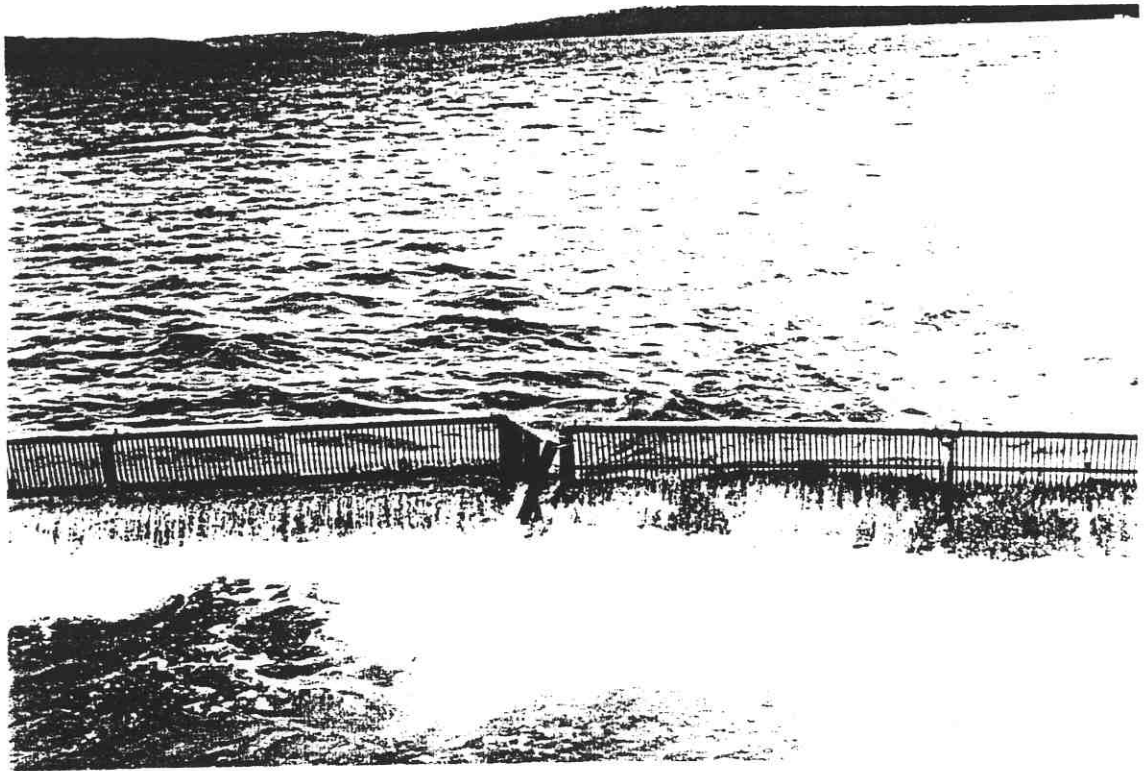
Figure Two-PHOTOS OF FISH GRATE AND DAM

The fish grate is placed directly on top of both concrete sills. The grate consists of a bottom plate—approximately 3 inches wide by one quarter inch thick, a top bar—approximately 2 inches in diameter, and in between are metal slats—approximately 12 inches in height, one-eighth inch thick, and one inch wide (see photo in Figure Two). The opening between sills has been barricaded by different materials such as three wooden slats (shown in photo) and is currently blocked by a metal grate.

The Walloon Lake dam is located at the southeast portion of the lake. The concrete spillway consists of two sills, the south sill is approximately 21 feet long and has an elevation of 687.23 and the north sill is approximately 14 feet long and has an elevation of 686.50 (elevations recorded by Charlevoix Abstract and Engineering Co., 1974). The difference between the sills is .71 feet (8.52 inches). Based on measurements taken for the "Project Vigilant" studies (Limno-Tech, Inc., 1984) elevation of Walloon Lake varies seasonally but is generally in the range of 687.04 feet to 687.86. Walloon Lake is about 100 feet above the elevation of Lake Michigan.
